Technical Service Bulletin

Topic	Air Suspension Warnings - EFP does not communicate with ODIS Continental GT/GTC /Flying Spur 25MY
Market area	Bentley: worldwide (2WBE),China 796 VW Import Comp. Ltd (Vico), Beijing (6796)
Brand	Bentley
Transaction No.	2078265/2
Level	EH
Status	Released for publishing
Release date	Feb 16, 2026

25MY Continental GT/GTC and Flying Spur

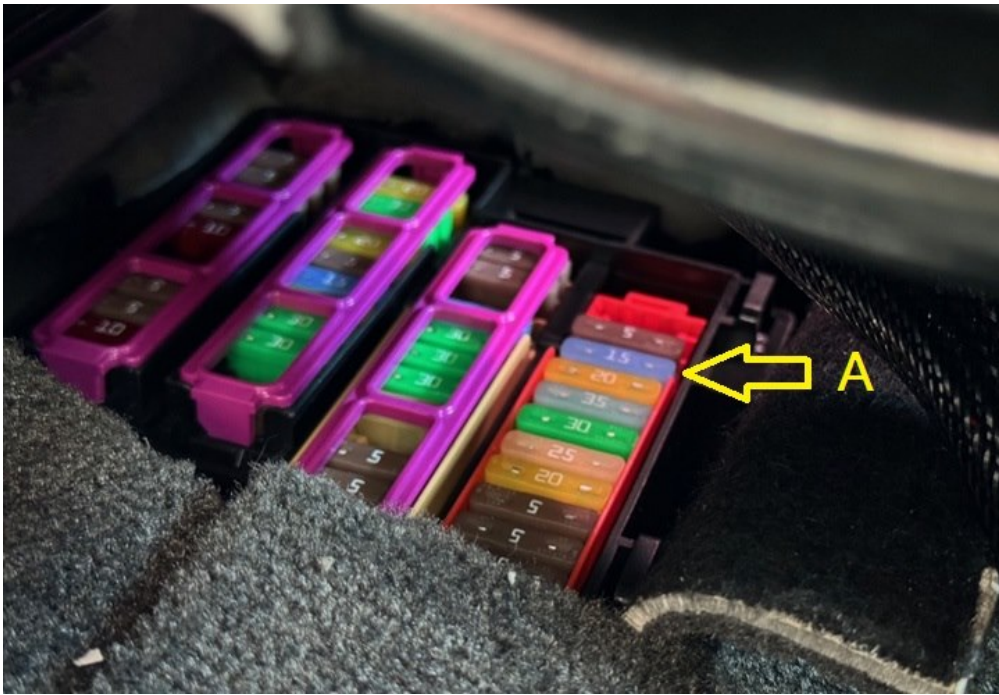
Figure 2. Fuse control panel

- No DTCS will be present as the Chassis control module (EFP) does not communicate and cannot be reached with diagnostic tools.
- Fault does not clear following an ignition cycle.

3. Perform a reset of the suspension control module supply fuse (address word 0074) by removing the KL30 15A fuse - location 4 located on the red fuse holder N (rearmost of all 4) for 10 seconds.

- Fuse carrier 2 (ST4 RED – LHS Font Seat, floor) (Figure 2, A)

Tip: You must consult the applicable wire diagram for the vehicle you are working on if there is no fuse in position F4, or the fuse in position F4 is not 15A.
