## Technical product information

<b>Topic</b>	Front Passenger Airbag Indicator Lamp - Illuminated / Indicator Not Functioning
<b>Market area</b>	Bentley: worldwide (2WBE),China 796 VW Import Comp. Ltd (Vico), Beijing (6796)
<b>Brand</b>	Bentley
<b>Transaction No.</b>	2080902/1
<b>Level</b>	EH
<b>Status</b>	Released for publication
<b>Release date</b>	Feb 16 2026

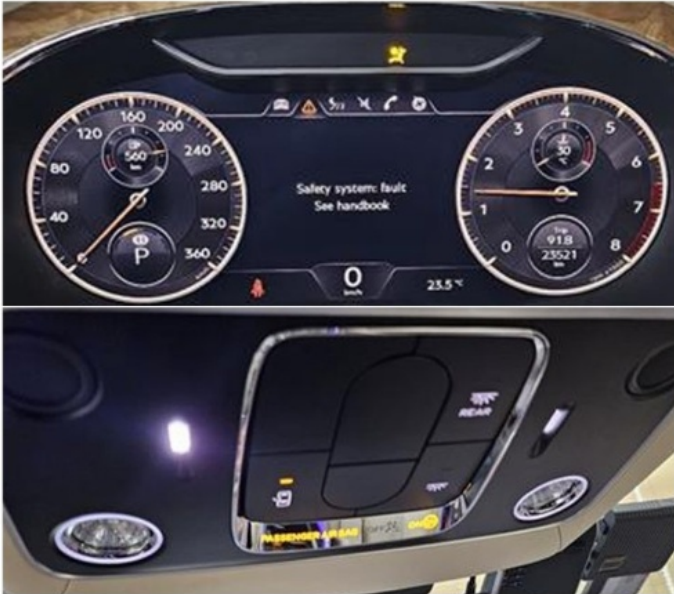
The customer reports that the airbag warning lamp is illuminated in the instrument cluster and the front passenger airbag indicator lamp within the roof console does not function.

**Figure 1.** Airbag warning illuminated in the instrument cluster

Customer findings of airbag warning lamp illuminated in the instrument cluster verified in the workshop with the following DTCs stored in the airbag control module (address word 0015):

- B101629: Front passenger airbag - disabled- indicator lamp implausible signal – symptom code 9442857
- B12F129: Front passenger airbag -enabled- indicator lamp implausible signal – Symptom code 9629993
- B151329: Front Passenger airbag indicator lamp, text illumination implausible signal – symptom code 9769769

An implausible signal from the passenger airbag indicator is being reported to the airbag control unit. This behaviour is consistent with a connection or fitment issue at the roof console indicator module. A connection check and module fit inspection is required. Refer to the *Measure* section for the approved service action.

1. Inspect the roof console module and ensure the housing is fully clipped together.  
Gaps or incomplete assembly may cause the indicator not to function.
2. Remove the front roof console module, check all electrical connectors at the roof console module.  
Refer to ElsaPro → Rep. Gr. 70 'Front roof console - To remove and fit'
3. Confirm terminals are fully seated, check for bent, recessed or damaged pins
4. Disconnect and reconnect the roof console module.
5. Clear DTCs and recheck operation.
6. If the warning lamps clear and the system functions normally, no further action is required.
