Technical Service Bulletin: TSB260017

Incorrect Aftertreatment Regeneration Permit Switch Trims

- B6.7 CM2450 B155B
- L9 CM2450 L126B
- X12 CM2450 X137B
- X15 CM2450 X142B

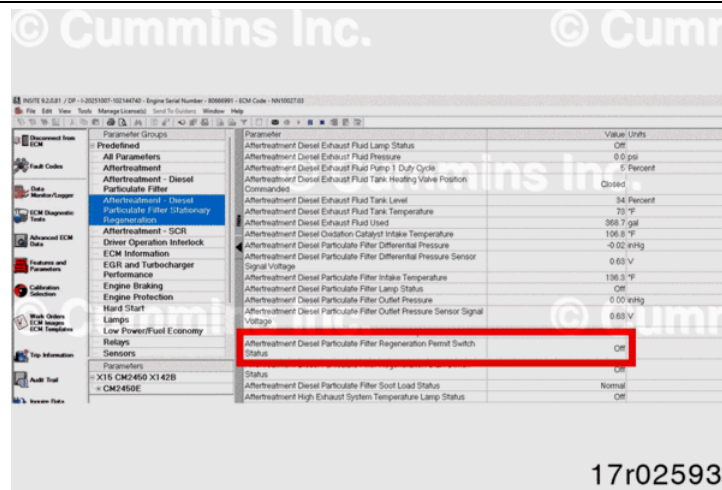
Figure 2, INSITE™ Electronic Service Tool Data Monitor and Parameters

1. Troubleshoot fault code 14356 if active before troubleshooting any of these fault codes 1921, 1922, 1981, 2639, 4213.
2. Check the functionality of Regeneration Permit Switch
 - 2a. In the INSITE™ Electronic Service Tool go to Data Monitor/Logger and under the Parameter Groups select "Aftertreatment – Diesel Particulate Filter Stationary Regeneration".
 - 2b. Find Parameter "Aftertreatment Diesel Particulate Filter Regeneration Permit Switch Status". Reference Figure 2.

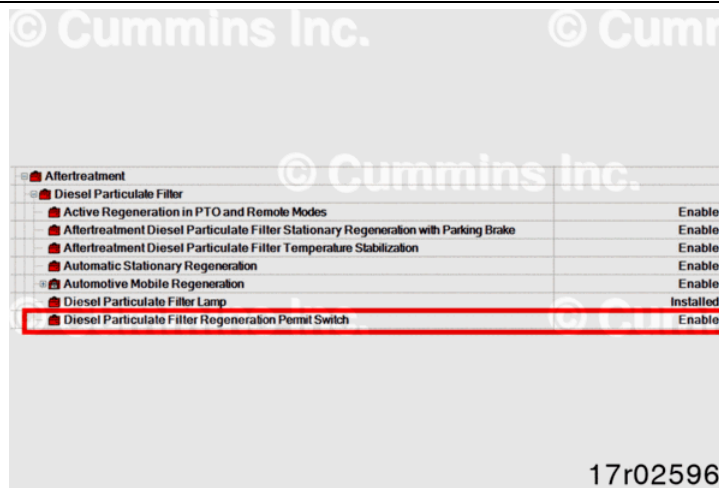
Figure 5, INSITE™ Electronic Service Tool Features and Parameter Trims Aftertreatment Enable

5b. Unit has a hardwired regen inhibit switch, but multiplexing is enabled.

5bii. Find and expand Aftertreatment > Diesel Particulate Filter and enable Diesel Particulate Filter Regeneration Permit Switch if the trim is set to disable. Reference Figure 5 for the correct setting.
