## Technical product information

<b>Topic</b>	Guide on My Bentley App - Error MBB.HTTP.2 When Using Remote Services
<b>Market area</b>	Germany E02 Bentley rest Europe (6E02),United Arab Emirates E06 Bentley Middle East and Africa (6E06),United Kingdom E01 Bentley UK (6E01),United States E05 Bentley USA and rest America (6E05)
<b>Brand</b>	Bentley
<b>Transaction No.</b>	2080955/1
<b>Level</b>	EH
<b>Status</b>	Released for publication
<b>Release date</b>	Feb 23 2026

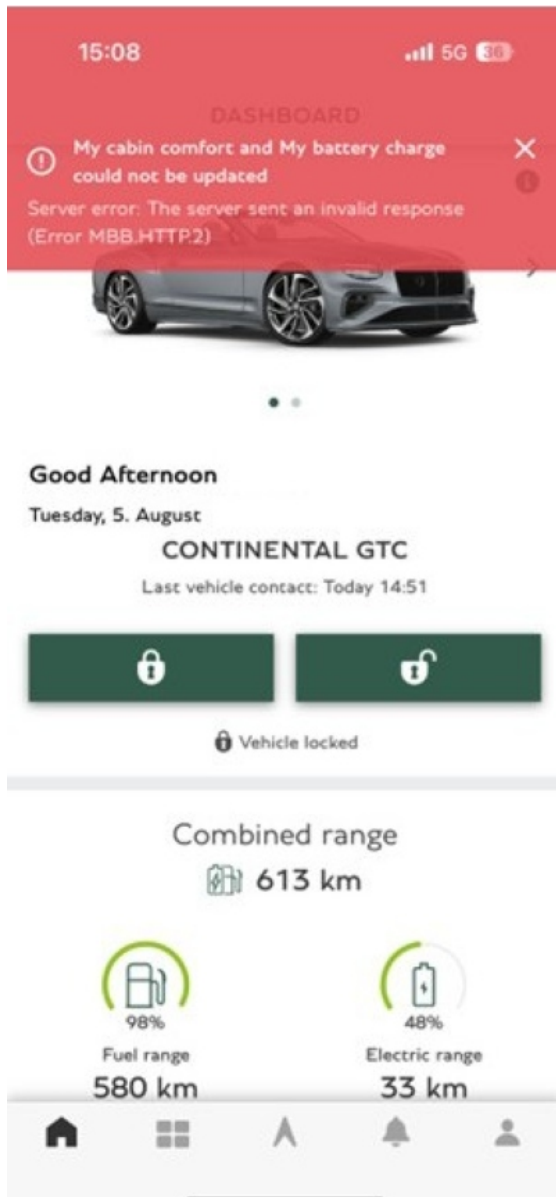
Customers may report that the My Bentley App displays an MBB.HTTP.2 error when attempting to use remote services such as Remote Climate or Remote Charging. The functions fail to initiate from the app.

Figure 1. My Bentley App MBB.HTTP.2 error

The MBB.HTTP.2 error is caused by remote climate and charging timers being set to invalid or nonnumerical values within the vehicles MMI. If either timer is set to an invalid state, remote commands from the app cannot be processed and the error is triggered.

1. Check the remote climate timer and the remote charging timer via the vehicles MMI display.

If either value displays incorrectly or appears blank/invalid (NaN) as shown in figure 2, set the timers to any valid time (e.g., 09:00 the following day).

3. If valid timers are already set and the error persists, perform a factory reset of the MIB.

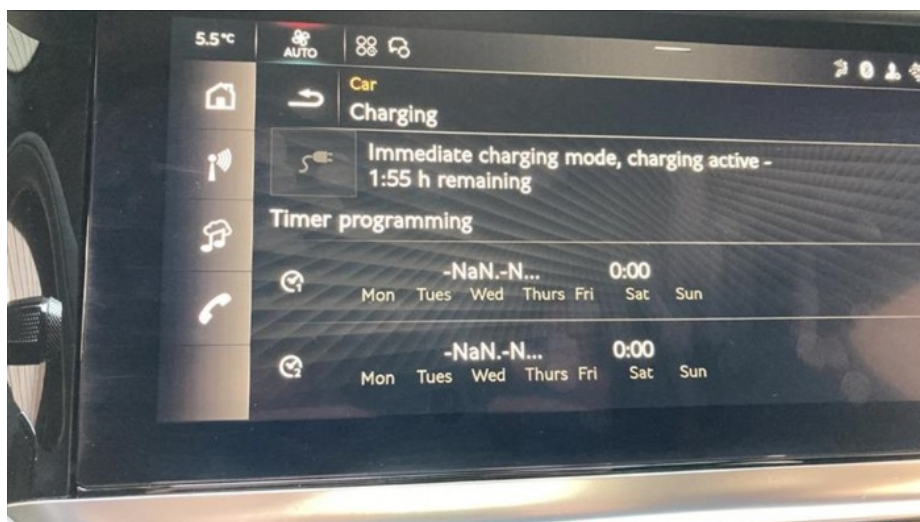
Figure 2. MMI displaying incorrectly set charge timers

2. Ensure both are set to valid times.
