Technical product information

Topic	Temperature Pop-Up No Longer Displayed in the MMI Display Continental GT/GTC /Flying Spur
Market area	Bentley: worldwide (2WBE),China 796 VW Import Comp. Ltd (Vico), Beijing (6796)
Brand	Bentley
Transaction No.	2080951/1
Level	EH
Status	Released for publication
Release date	Feb 23 2026

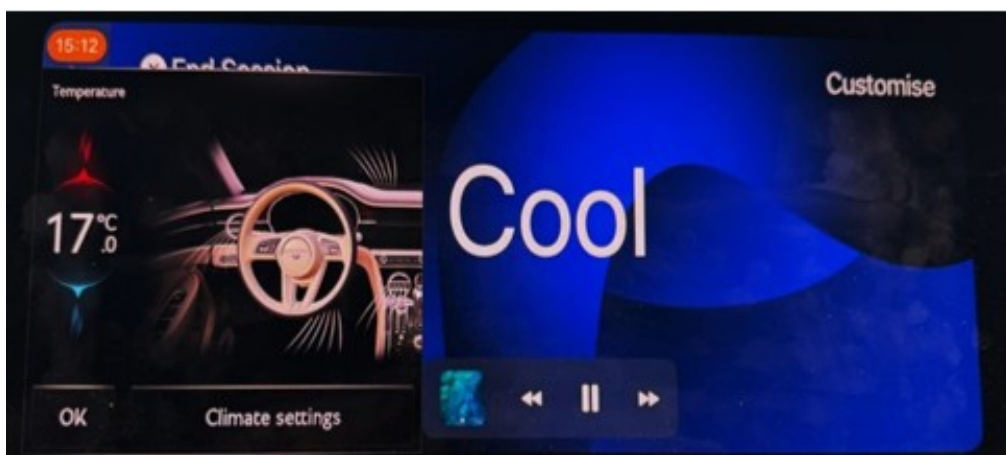
Figure 1. Temperature pop-up present in the MMI display

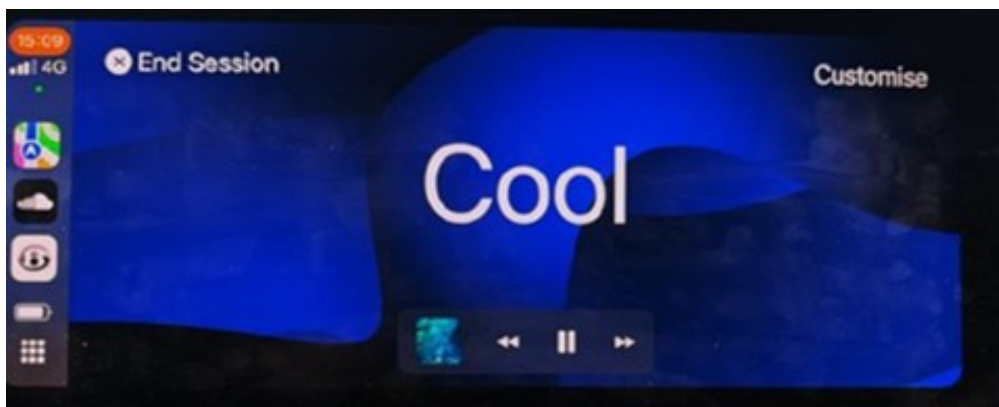
Figure 2. Temperature pop-up no longer presents in the MMI display

Customer query is verified that the temperature popup previously shown on temperature adjustment is no longer displayed. This behaviour matches the before and after images shown above. No relevant DTCs are stored.

Latest HVAC software update introduces robustness improvements for Auto On functionality. The update also intentionally removes the temperature popup display when the temperature is adjusted via the app or the rotary dial.

This new behaviour is by design and not an indication of a system fault.

If a customer queries the missing temperature popup or reports a change in HVAC behaviour, inform them that:

- The removal of the temperature popup is intentional with the new HVAC software.
- The change forms part of the HVAC robustness improvements.
- This behaviour is correct and expected on vehicles updated to or built with latest Baseline Intergraton (BiL) software.
