## Technical Service Bulletin

**26-EM-007H**

**ELANTRA (CN7)**

**SUBJECT: STEERING WHEEL VIBRATION FROM COOLING FAN OPERATION**

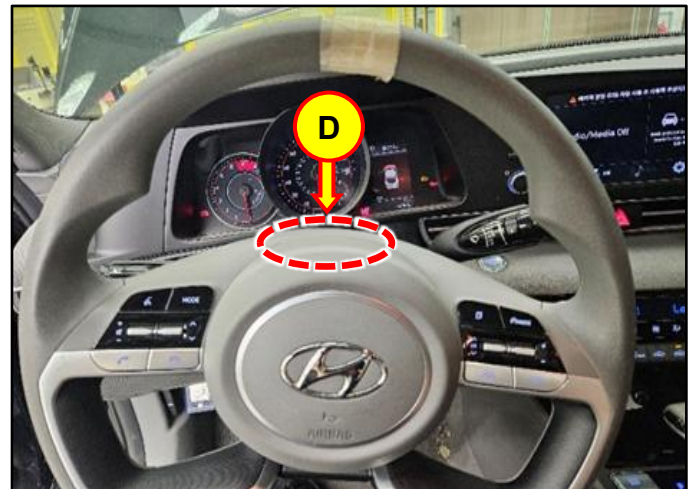
5. While cooling fan is operating at high speed, place your hand on the steering wheel in the location indicated (D) and inspect for excessive vibration.

- If **NO** excessive vibration is felt, this TSB does **NOT** apply. Service procedure is complete.
- If an excessive amount of vibration is felt, proceed to the [Engine Cooling Fan Replacement](#) procedure.

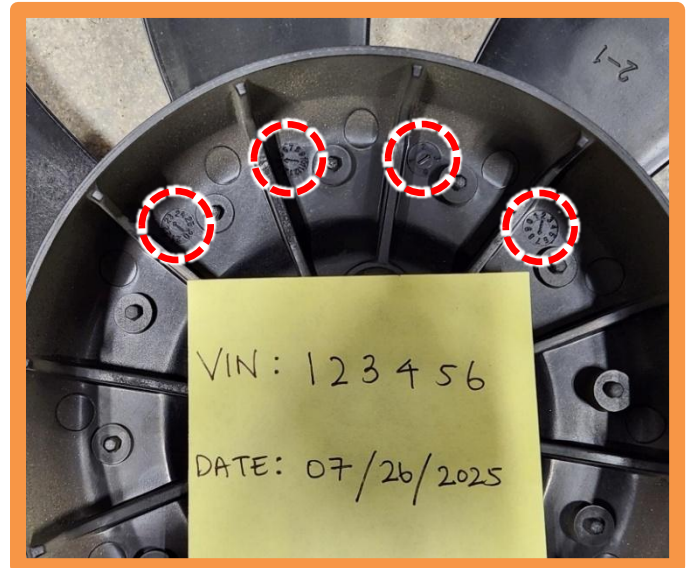
Using the STUI camera function, take a photo of the mold date stamp on the original cooling fan blade.
