HYUNDAI Technical Service Bulletin	GROUP ADAS	NUMBER 26-AD-001H
	DATE FEBRUARY 2026	MODEL(S) SEE BELOW
SUBJECT: FRONT VIEW CAMERA WARNING AND CALIBRATION (DTC C272246)

C272246 – System Out of Calibration

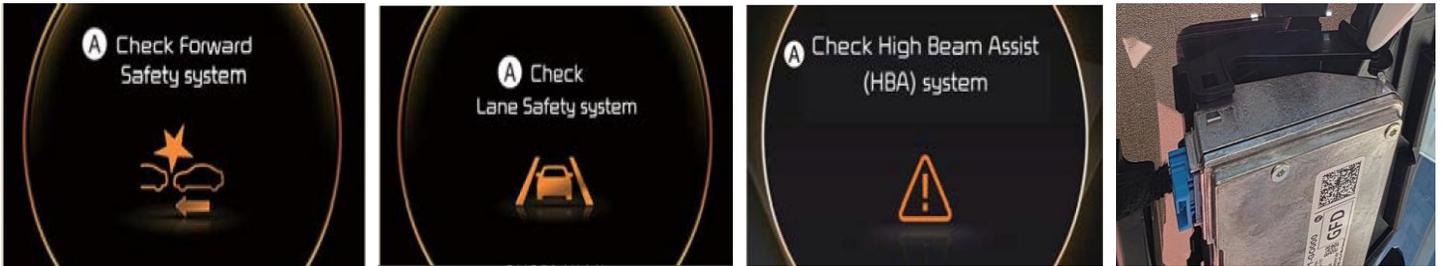
Possible Warning lights due to the front camera exceeding its calibration tolerance:

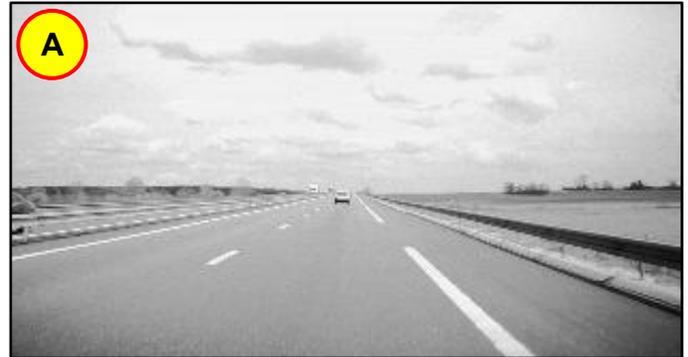
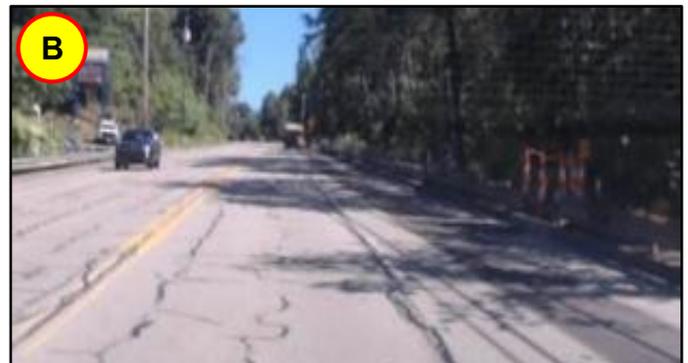
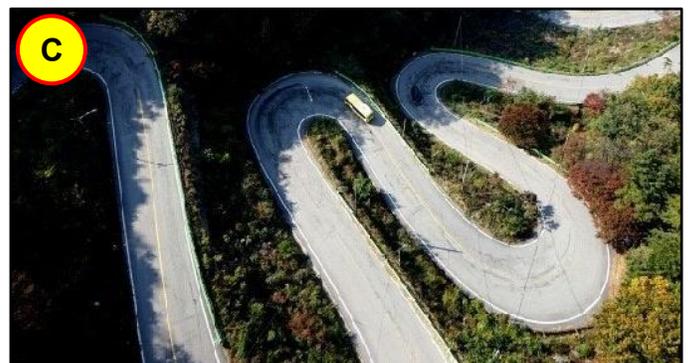
Calibration may fail when conducted on a road with too much surface damage (B) or too many curves (C).

2. Confirm and if necessary, address the concern for the possibility of the following conditions:
 - Remove and re-install the front camera in case it was seated improperly.
 - Check all tires pressure, ensuring they are set to specification.
 - Ensure there is **NO** excessive load on one side of the vehicle.
 - Ensure the vehicle is not leaning too much in the front end or rear end due to excessive load.
3. Test drive the vehicles under the following conditions:
 - Time: **5 minutes**
 - Speed: Over **18.6 MPH (30 KPH)**
 - Road: Straight with minimal curves (A)
