Technical Service Bulletin

GROUP EV SYSTEMS	NUMBER 26-EV-002H
DATE FEBRUARY 2026	MODEL(S) IONIQ 5 (NEA EV)

SUBJECT: HV BATTERY INSPECTION & REPLACEMENT

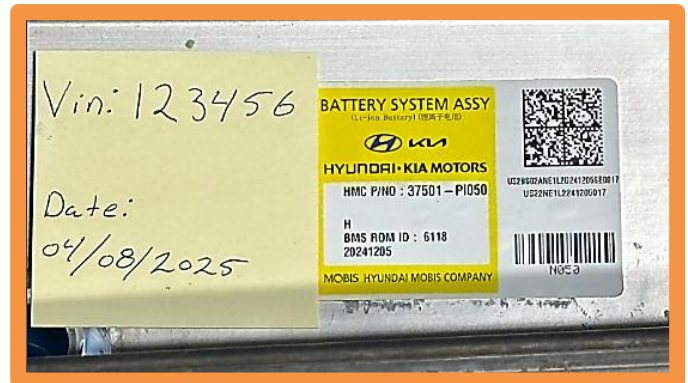
Using the STUI camera function, take a photo of the new BSA's part label.
