<b>HYUNDAI</b> <b>Technical Service Bulletin</b>	GROUP <b>CAMPAIGN</b>	NUMBER <b>26-01-015H-1</b>
	DATE <b>MARCH 2026</b>	MODEL(S) <b>SANTA FE (MX5A)</b>
<b>SUBJECT:</b> FPM SOFTWARE UPDATE (LIMITED COVERAGE CAMPAIGN LA6)

This TSB supersedes 26-01-015H to revise the SST Information section and to remove the Configuration of Ethernet Communication on Tablet PC procedure.

**Description:** Certain Santa Fe (MX5A) vehicles may experience a discharged battery condition due to the Fingerprint Module (FPM) not entering 'SLEEP' mode when the ignition is turned off. This bulletin provides instructions to perform a software update with revised logic for the FPM.

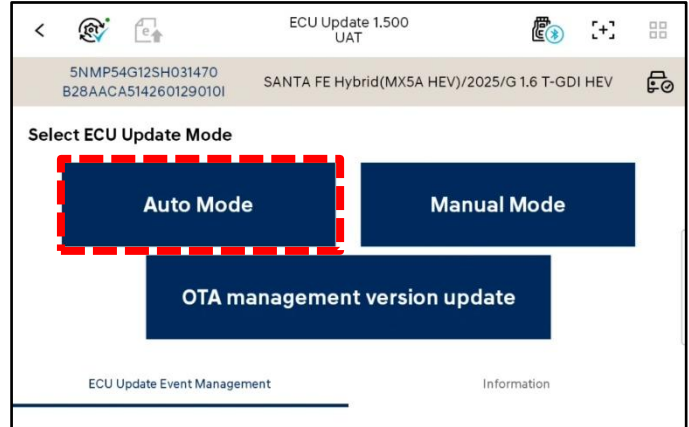
1. Perform the ECU update in **Auto Mode**.

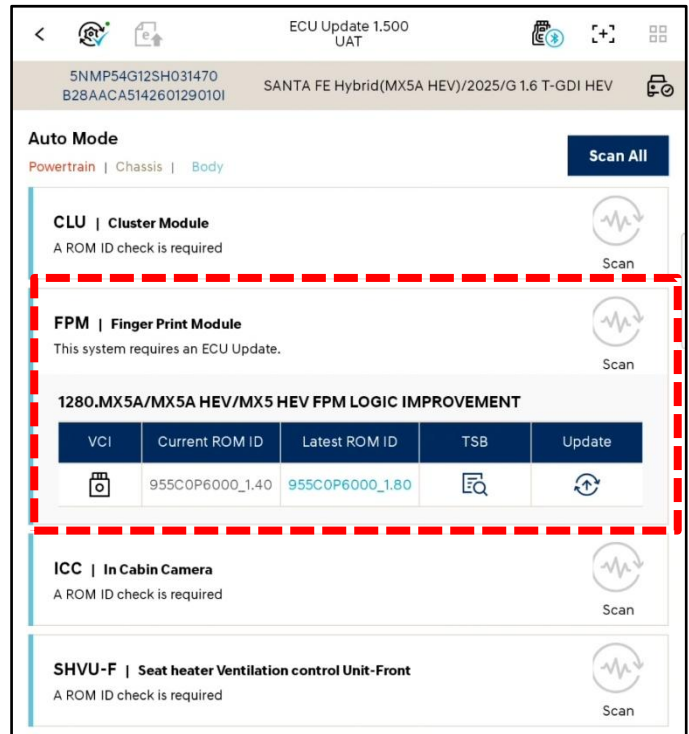
2. Select the **FPM** system to scan the vehicle’s current ROM ID.

Check the current ROM ID version and compare it to the ROM ID Information table before attempting to perform the software update.

If the update fails, remove the power connector from the in-cabin fuse box for at least **5 seconds**. Reassemble and retry the update.

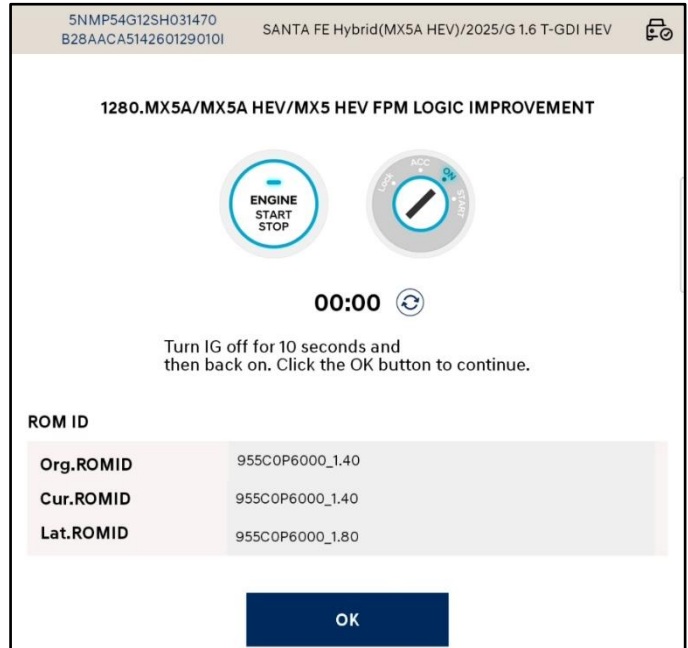
- After the ECU update process shows 100% complete, follow the prompts on the screen to cycle the ignition **OFF** for at least **10 seconds** to reset the control unit (certain models may take up to **30 seconds**).

Use the **Refresh** button to reset the timer.

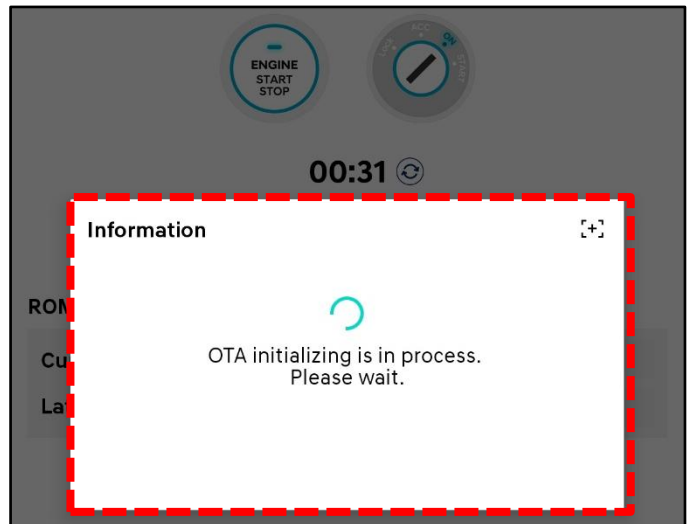
- OTA initialization should perform automatically:
  - If OTA initialization performs automatically, then proceed with the service procedure.

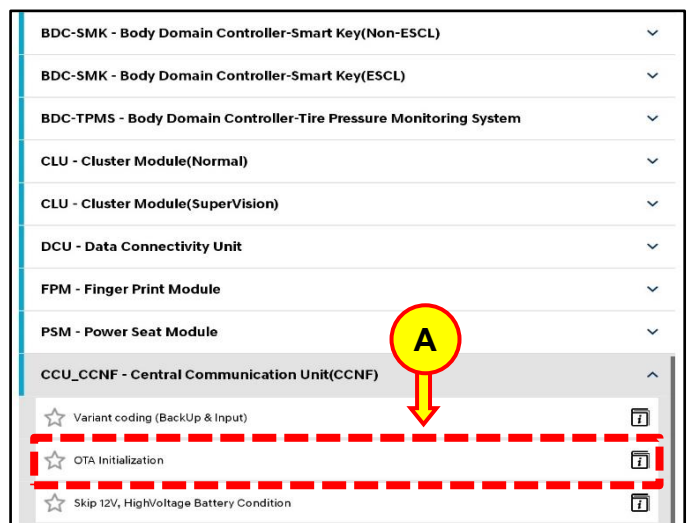
- If the OTA initialization process fails, complete it manually under: **S/W Management > CCU\_CCNF - Central Communication Unit (CCNF) > OTA Initialization (A)**.

Follow the instructions on the screen.

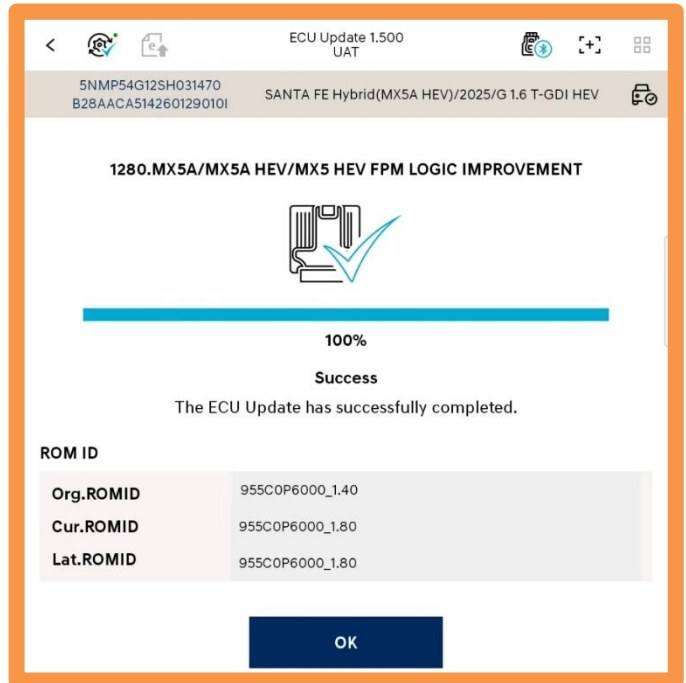
Using the tablet or GDS screen capture function, take a screenshot of the ECU update "Success" result screen.

Upload the photo to STUI.

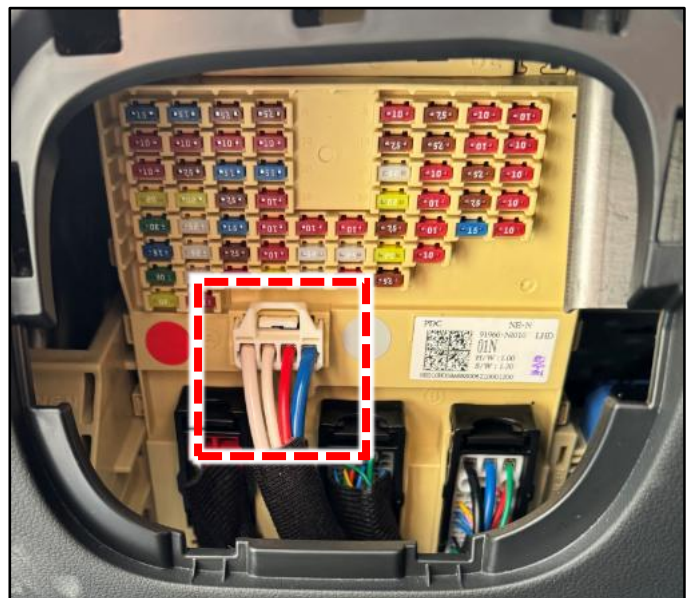
7. Disconnect the power connector of the indoor fuse box, wait at least **5 seconds**, then reconnect it.

Alternatively, disconnect the negative (-) **12V** battery terminal, wait **5 seconds**, then reconnect it.
