GENERAL MOTORS
DCS7452
URGENT - DISTRIBUTE IMMEDIATELY

Subject: N252531450 - Service Update
Missing Wheelhouse Sealer Bead

Models: 2025-2026 Cadillac XT5

N252531450 Missing Wheelhouse Sealer Bead

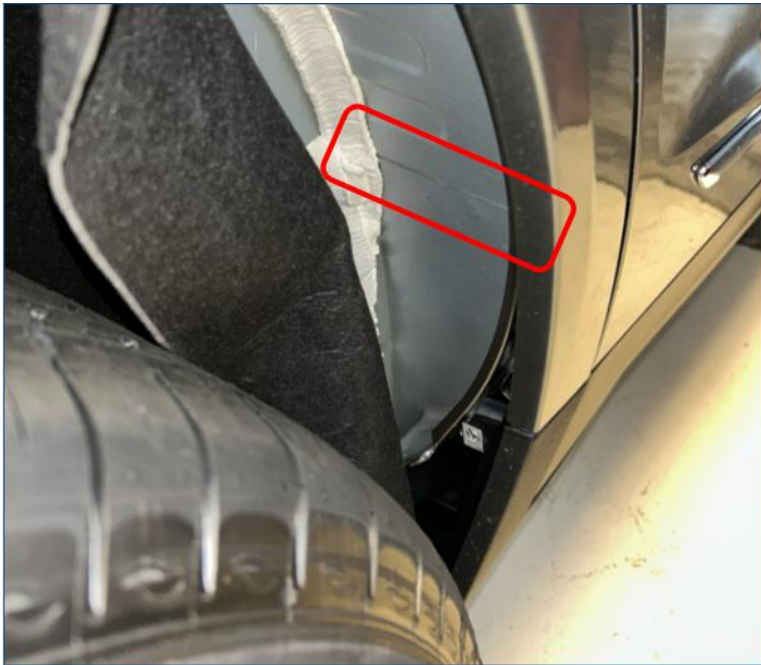
7099511

| Condition | Certain vehicles listed above may have a condition in which the sealer bead is missing on the right-side rear wheelhouse. |

4. Locate the body seam indicated above, located at the lower front portion of the wheel well. Clean the area thoroughly prior to applying seam sealer. Blow out the area with compressed air.
