Service Bulletin

Bulletin No.: PIT6209H

Subject: Update Failed See Dealer to Restore System Screen Recovery

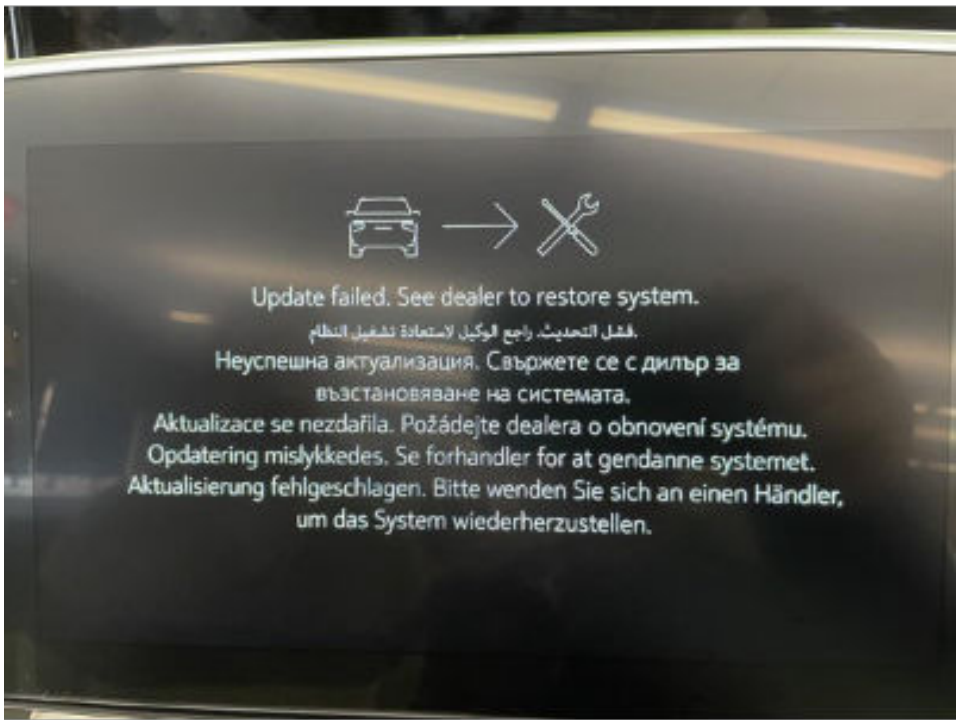
<p style="text-align: right;">6873187</p>
<p>Cause</p>	<p>The cause of the condition may be software anomalies.</p>

<p>Condition</p>	<p>A customer might bring the vehicle in with radio showing a vehicle and an arrow pointing to a wrench. The recover method in Radio Malfunction may not work.</p>
