Service Bulletin

Bulletin No.: PIT6494

Subject: Malfunction Indicator Lamp (MIL) DTC P3075- Radiator Inlet Hose Coolant Leak

Brand:	Model:	Model Year:		VIN:		Engine:	Transmission:
		from	to	from	to		
Chevrolet	Colorado	2023-2026		All	All	All	All
GMC	Canyon	2023-2026		All	All	All	All

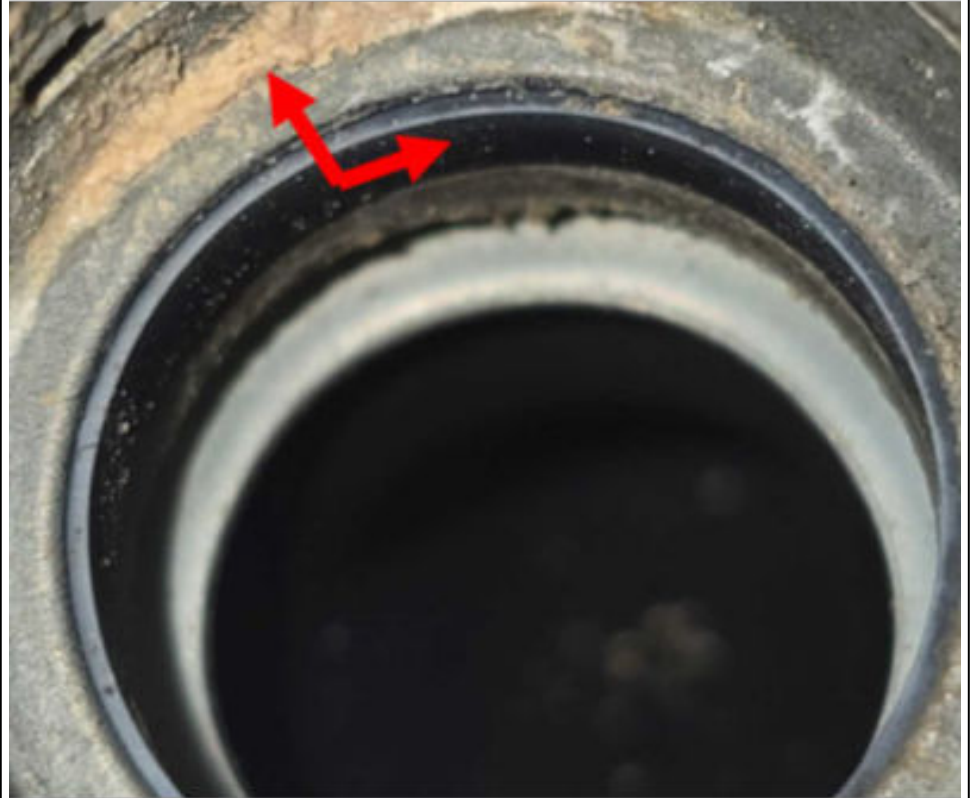
7097960

Involved Region or Country	North America
Condition	<p>Some customers may comment on one or more of the following:</p> <ul style="list-style-type: none"> A visible coolant leak or a low coolant level at the overflow reservoir. The Malfunction Indicator Lamp (MIL) illuminated in the Driver Information Center (DIC). <p>Technicians may observe:</p> <ul style="list-style-type: none"> Coolant leaking from the upper radiator inlet hose connection. DTC P3075 (Engine Coolant Flow Too Low) stored in the Engine Control Module (ECM). <p>Note: In some cases, the condition may be accompanied by DTC P3075.</p> <p>Note: If DTC P3075 is present without evidence of a coolant leak, follow the appropriate Service Information diagnostics.</p>
Cause	<p>The condition may be caused by coolant leakage at the upper radiator hose quickconnect fitting due to a degraded inlethose seal.</p> <p>This leakage originates from the radiator inlet hose seal itself and is not the result of a radiator failure. Seal wear may present with varying levels of residue or buildup depending on vehicle usage and operating environment.</p> <p>Visual inspection of a failed lip seal—typically showing material flattening and residue accumulation around the connection—indicates seal degradation rather than a radiator defect. See Graphic.</p>

1) Drain the cooling system. Refer to Cooling System Draining and Filling in SI.

2) Remove the Radiator Inlet Hose from the vehicle. Refer to Radiator Inlet Hose Replacement. Recommend using a lint-free (clean) cloth to wipe the radiator spigot prior to reassembling the hose to remove any residual contaminate that may be present from the coolant hose. The surface should be smooth and free of contaminate prior to installation of the new hose to prevent leakage.

Important: Do not use any lubricants, grease, or detergents to install the new radiator hose back onto the vehicle.
