Model series 232, model series 192 wind noises in the area of the mirror triangle on the front doors/side window panes

Topic number	LI67.30-P-080343
Version	1
Function group	67.30 - Side windows
Date	3/11/26
Validity	BR232, BR192
Reason for change	null

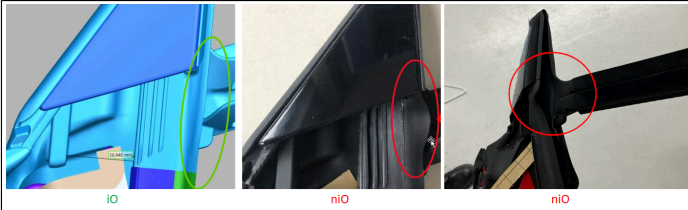
Attachments	
File	Description
Dichtung innen_Deformation_Welligkeit.png	Attachment 1: Check inner seal (SNR A2327203102/-3202)

- Check inner seal for deformations. To do so, observe attachment 1 and attachment 2. If a deformation (waviness) can be ascertained: Replace seal or reform back into place using heat and fix in place using cold.

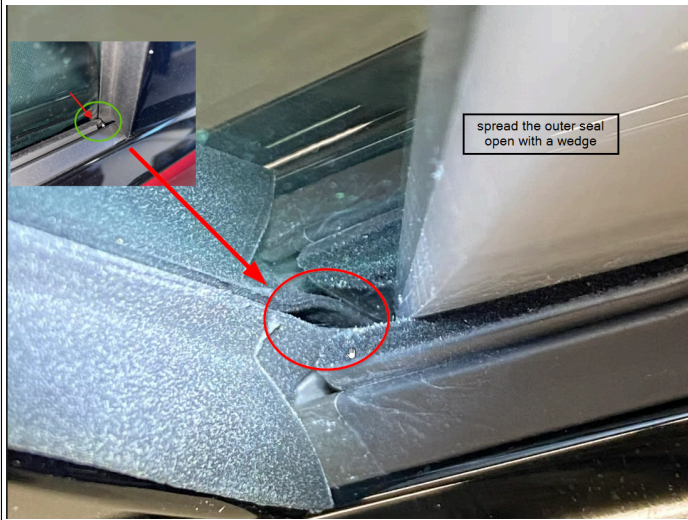
Attachment 2: Check inner seal for deformation by spreading out the outer seal with a wedge. Picture shows the not okay state

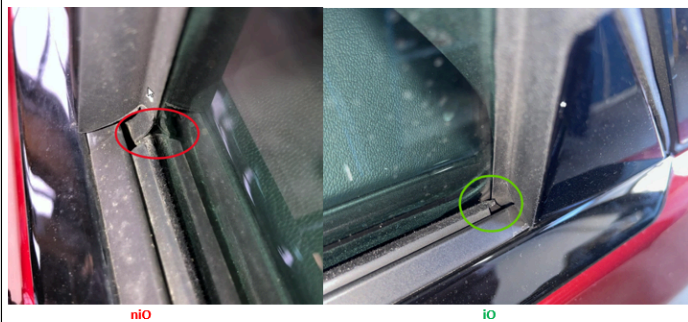
Attachment 3: Check outer seal (waistline trim strip) for collision with the vertical sealing lip of the mirror triangle.

- Check outer sealing rail to vertical sealing lip of the mirror triangle. To do so, observe attachment 3. If the sealing rail collides with the vertical sealing lip of the mirror triangle: Either route it such that it rests above the vertical sealing lip of the mirror triangle or shorten.

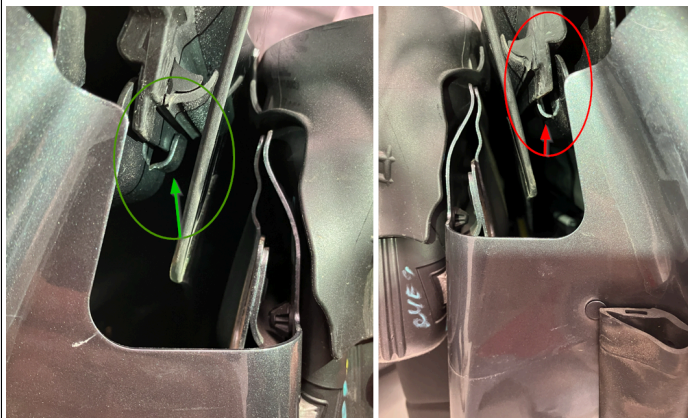
Attachment 4: Check the correct installation of the outer seal (waistline trim strip) in the three mounting straps of the door.

- Check external sealing rail for correct assembly. To do this, ensure that it is engaged into the three existing mounting straps on the door. See Attachment 4. Also ensure that the outer sealing rail is correctly positioned in the x-direction and closes off flush. See Attachments 5 and 6 for this. Also ensure during assembly that the outer sealing rail is inserted beneath the mirror triangle. See Attachment 7.

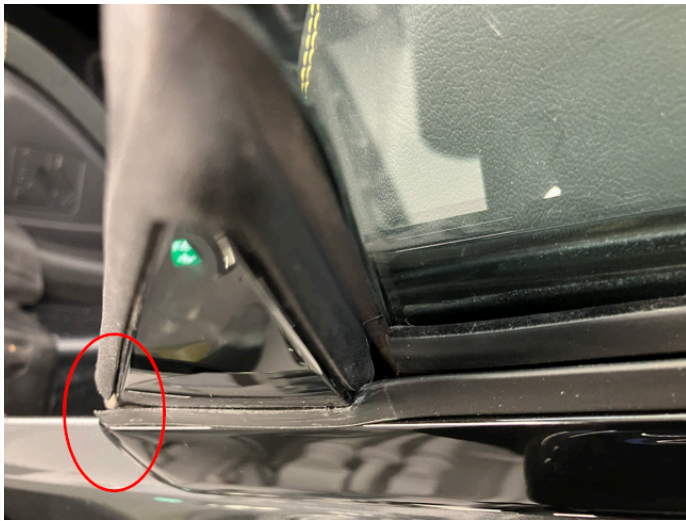
Attachment 5: Check the correct positioning of the outer seal (waistline trim strip) in the x-direction. Picture shows the not okay state

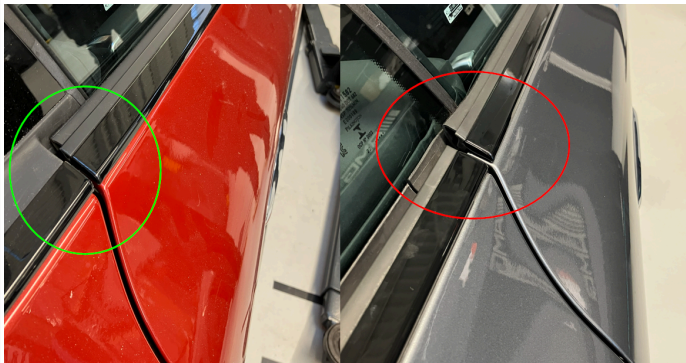
Attachment 6: Check the outer seal (waistline trim strip) for correct positioning.

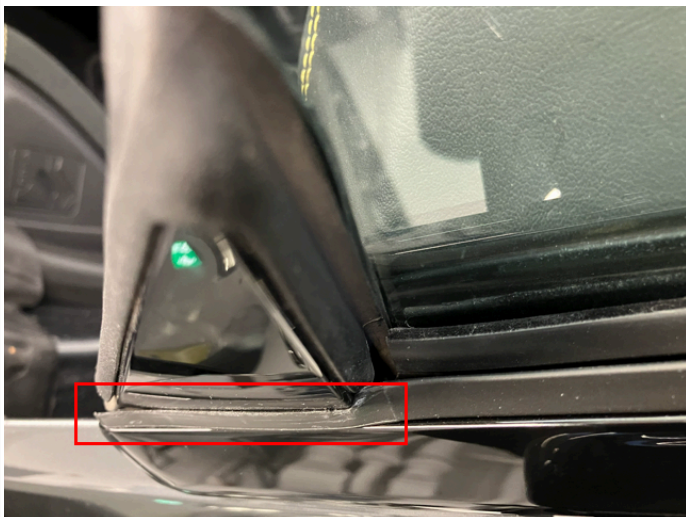
Attachment 7: Check the outer seal (waistline trim strip) for correct positioning in the mirror triangle area. Picture shows the not okay state

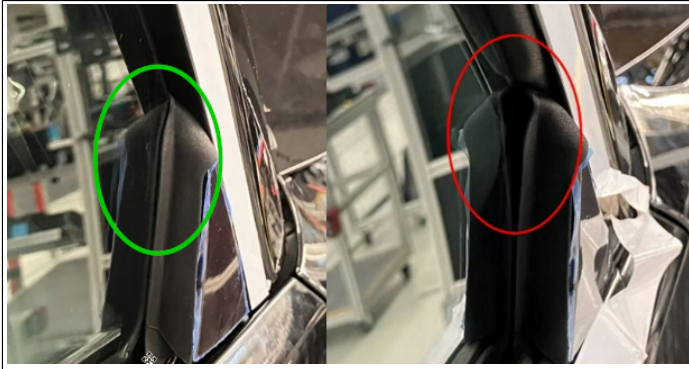
Attachment 8: Check the correct assembly of the inner seal and/or mirror triangle.

- Check the inner seal, especially in the mirror triangle area, for correct assembly. See Attachment 8.
