# Technical Service Bulletin

<b>GROUP</b>	<b>NUMBER</b>
<b>CAMPAIGN</b>	<b>26-01-022G</b>
<b>DATE</b>	<b>MODEL(S)</b>
<b>MARCH 2026</b>	<b>GV60 (JW1 EV)</b>

**SUBJECT:** PARKING DISTANCE WARNING (PDW) SOFTWARE UPDATE  
(SERVICE CAMPAIGN 919G)

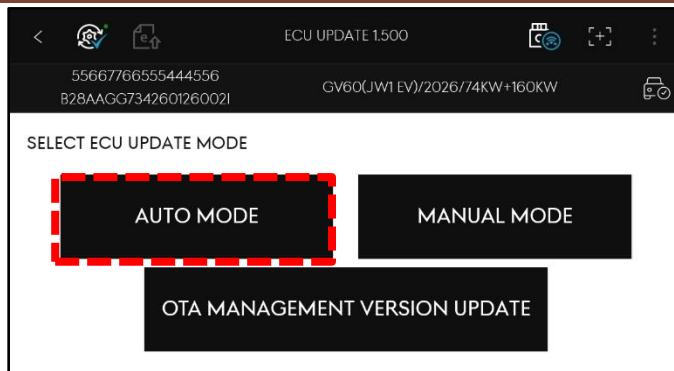
1. Perform the ECU update in **Auto Mode**.

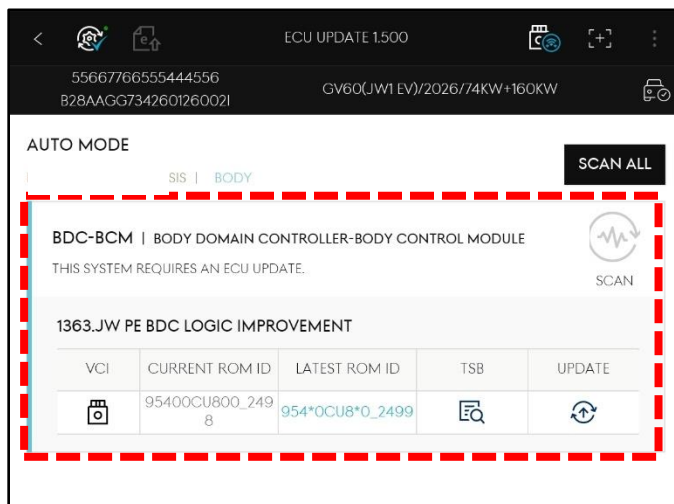
2. Verify the ROM ID by selecting the **BDC-BCM** system to scan the vehicle’s current ROM ID.

Check the current ROM ID version and compare it to the ROM ID Information table before attempting to perform the software update.

If the update fails, remove the power connector from the in-cabin fuse box for at least **5 seconds**. Alternatively, disconnect the negative (–) **12V** battery terminal and wait at least **5 seconds**. Reassemble and retry the update.

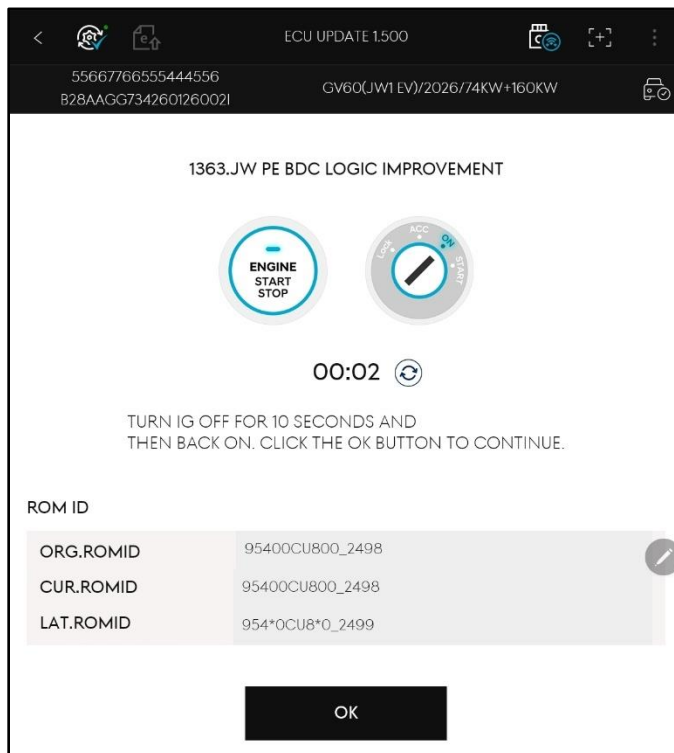
- Once the ECU update is 100% complete, follow the prompts on the screen to cycle the ignition **OFF** for at least **10 seconds** to reset the control unit (certain models may take up to **30 seconds**).

Use the **Refresh** button to reset the timer.

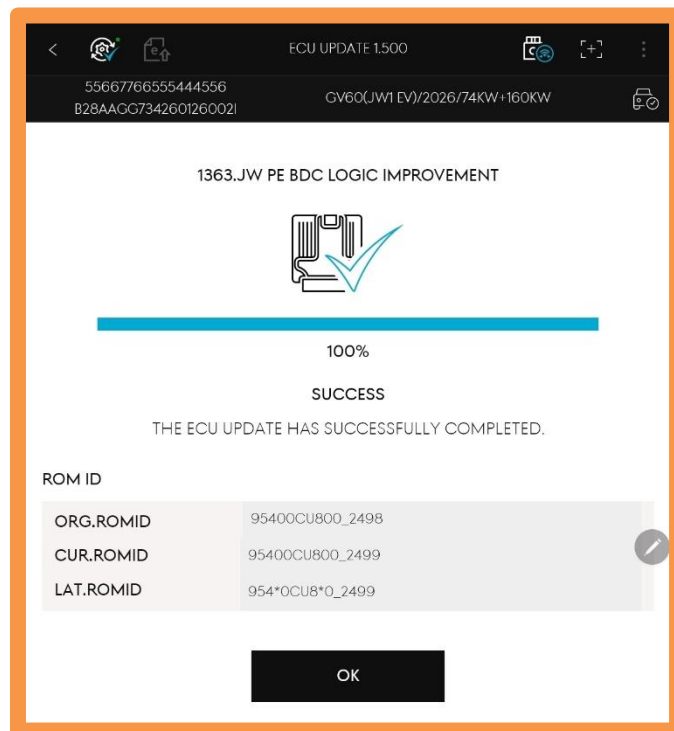
Using the tablet or GDS screen capture function, take a screenshot of the ECU Update "Success" result screen.

Upload the photo to STUI.

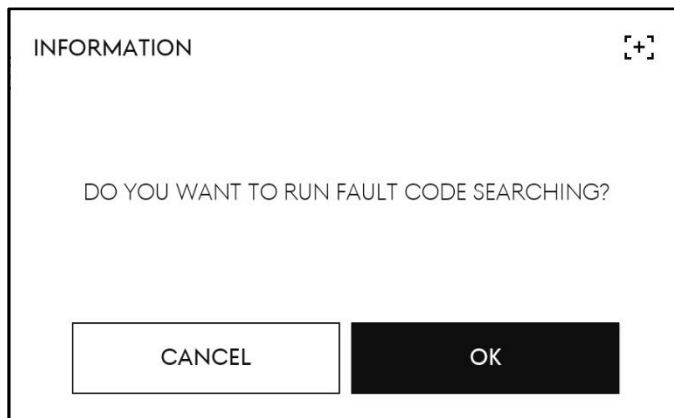
5. Perform an **All Systems Fault Code** search and erase DTC history that had incidentally occurred from the ECU update.
