GROUP	MODEL
Subsequent Repair Action	2015-2019MY Soul EV (PS EV)
NUMBER	DATE
SC267Z (Rev 2, 03/04/2026)	September 2023

HIGH-VOLTAGE BATTERY PACK ASSEMBLY REPLACEMENT (SC267Z)

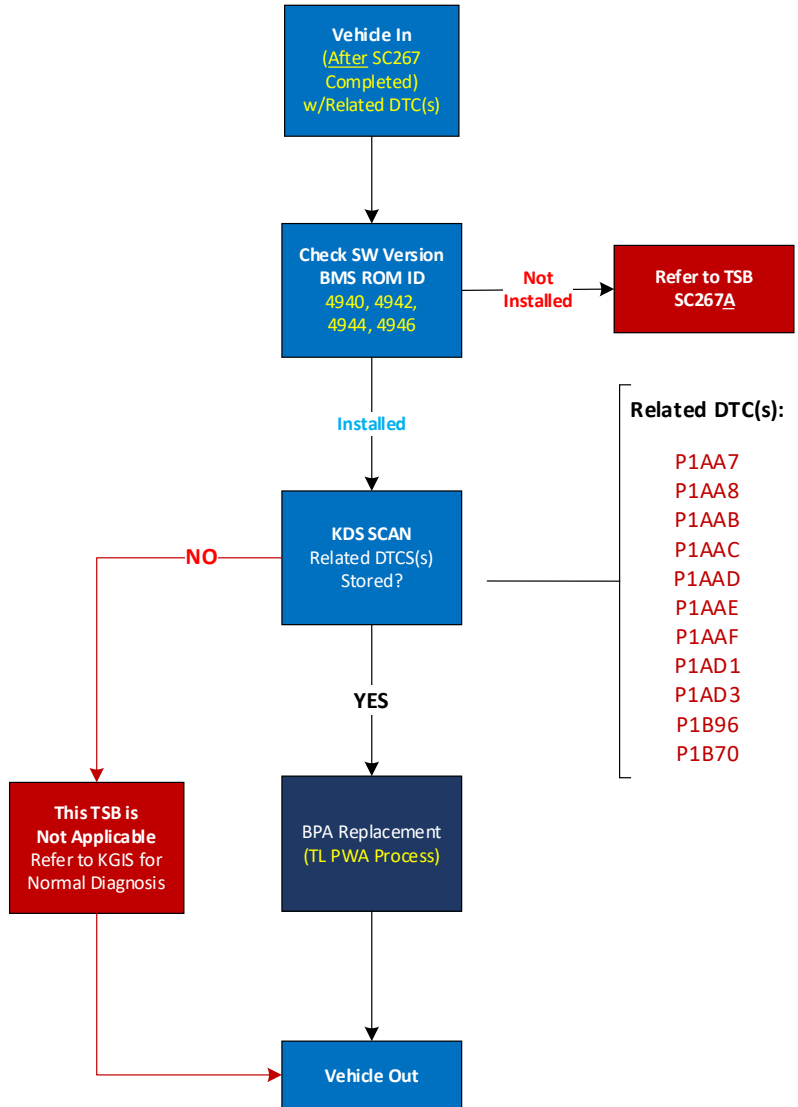
Flowchart:

This publication is only applicable on a subject vehicle that has already had SC267 completed on a previous visit which has the 'latest' BMS software. The subject vehicle must have one or more of the related DTC(s) stored listed in this publication in order to claim the BPA replacement. Any other DTC stored must be diagnosed by referring to KGIS and may not be claimed under this Subsequent Repair Campaign.

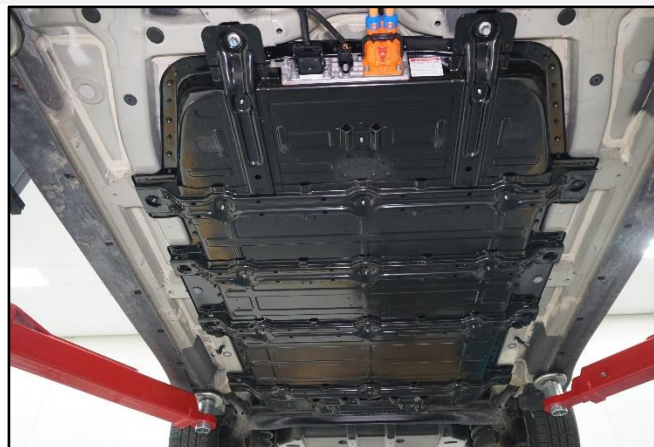
15-17MY ONLY new PN BPA is equipped with a "new" type harness. **(Rev 1) removed harness swap.**

1. Replace the HV BPA by referring to "EV Battery System → High Voltage Battery System → Battery Pack Assembly → Repair procedures (Removal)" in the applicable Shop Manual on KGIS. **Note:** Dealer must obtain TL PWA.

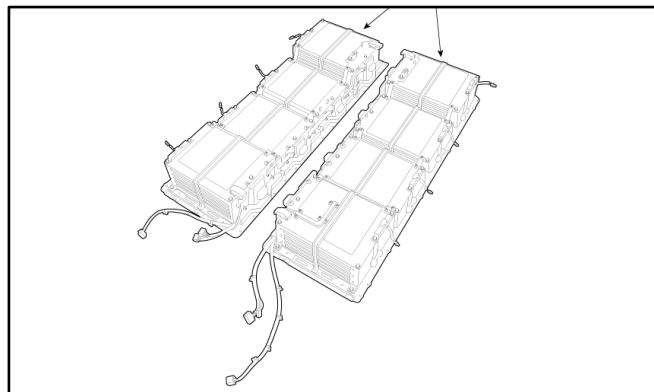
3. **Note:** The battery pack assembly (BPA) consists of two (2) (left and right) battery packs.

18-19MY ONLY new BPA is equipped with the "new" type harness. There is no need to swap.

4. Reinstall all removed parts in the reverse order of removal.
5. Clear related DTC(s) using KDS.
6. Confirm normal vehicle operation.
