2015-2017MY  
Soul EV (PS EV)

SC310Z (Rev 1, 03/04/2026)

## SUBSEQUENT REPAIR ACTION

## HIGH-VOLTAGE BPA REPLACEMENT

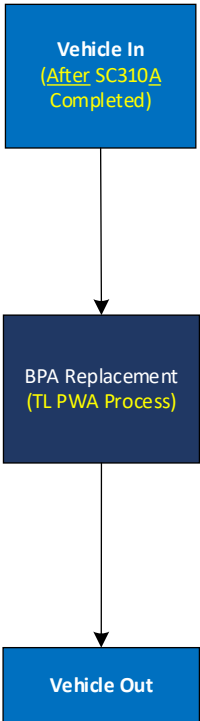
Flowchart:

- SC310Z →'Vehicle In' after TSB SC310A completed and 'related' DTCs are stored.

One or more of the 'related' DTC(s) stored:

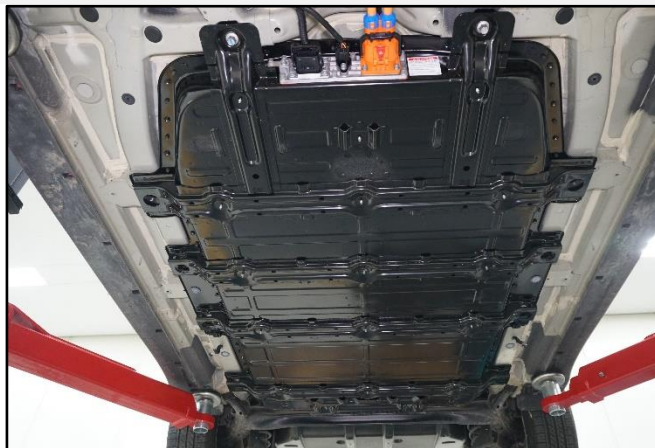
New PN BPA is equipped with a "new" type harness.

**Note:** SST OK375 E4300 BPA lifting jig and crane jack (A) are required.
