GROUP	MODEL
BOD	2023-2024MY K5 (DL3a)
NUMBER	DATE
350	March 2026

TECHNICAL SERVICE BULLETIN

CUSTOMER ACTION: CHROME TRUNK LID MOLDING REPLACEMENT (CA2514)

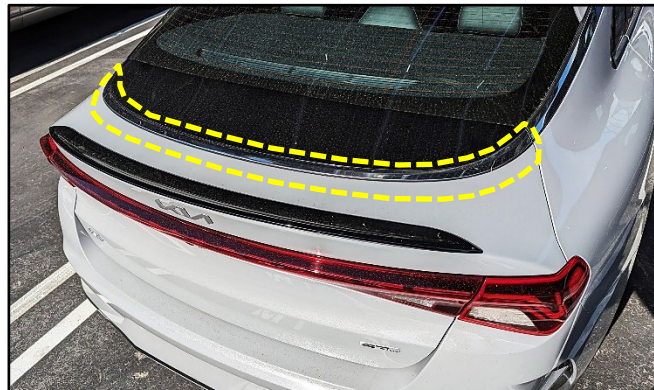
This bulletin provides information regarding replacement of the chrome trunk lid molding on certain 2023-2024MY K5 (DL3a) vehicles produced from October 3, 2022 through January 23, 2024. The chrome faceplate may be partly loose while remaining secured to the molding and vehicle. Follow the procedure outlined in this publication to replace the molding on the applicable vehicle. Before conducting the procedure, verify that the vehicle is included in the list of affected VINs.

1. Remove the rear trunk lid garnish assembly (A) by referring to "Body (Interior and Exterior) → Body Side Molding → Trunk Lid garnish → Repair Procedures" in the applicable Shop Manual in KGIS.
2. Carefully place the removed rear trunk lid garnish assembly face down over a clean cloth to protect the gloss black painted surface.
