GROUP	MODEL
ELE	2025MY EV9 (MV1a)
NUMBER	DATE
392 (Rev 1, 03/06/2026)	August 2025

## TECHNICAL SERVICE BULLETIN

### BSA REPLACEMENT GUIDANCE

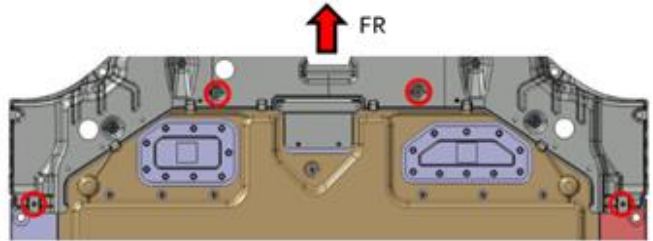
- The 'Front Under Cover Assy' are interchangeable between MV1 and MV1a (37501-XA250 to 37501-DO050). **However, since the underbody cover hardware differs between models, the underbody cover hardware must be replaced simultaneously when replacing the BSA.**

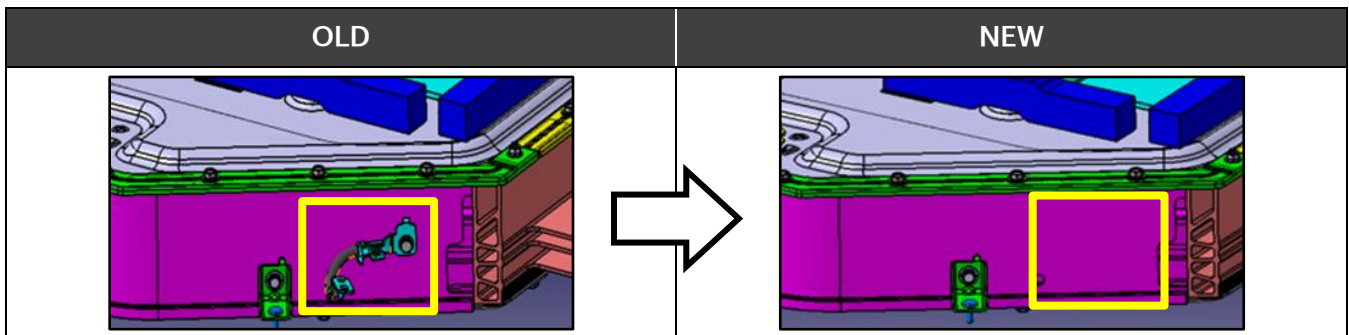
If you are replacing a high-voltage battery with an identical part number, replacement of the underbody cover fixing hardware is not required.

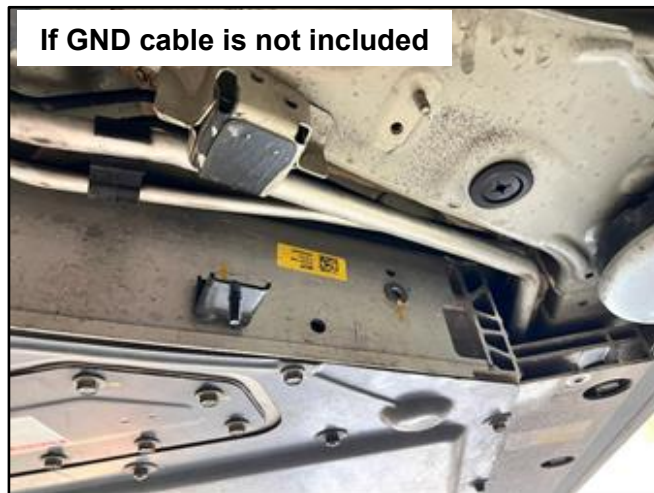
- If the replacement Battery System Assembly (BSA) does not include a ground (GND) cable, then the GND cable does not need to be installed.

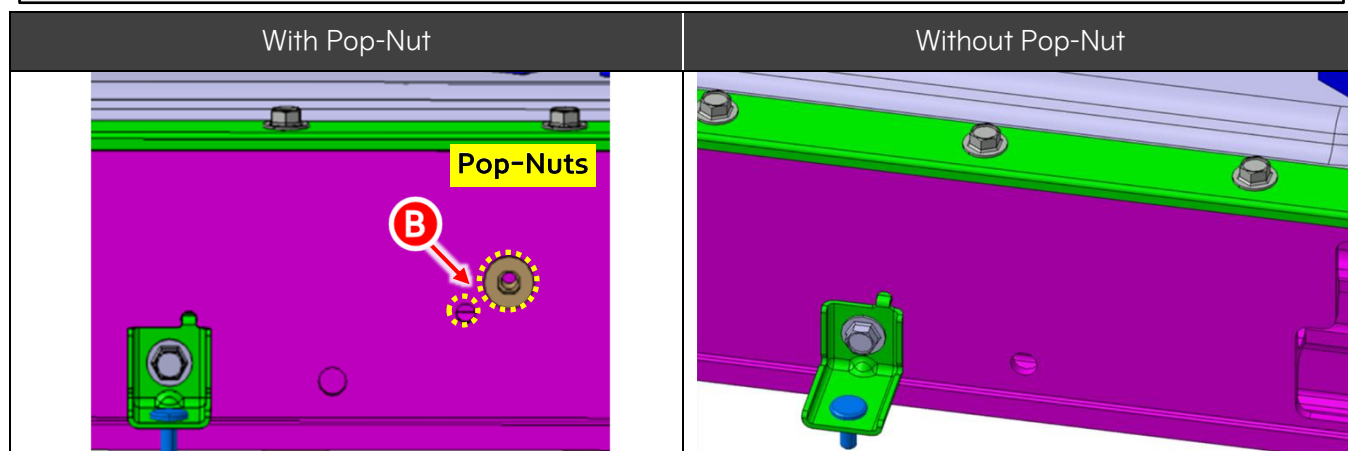
Some Battery System Assemblies (BSA) may feature pop-nuts (B) on the case; however, the presence of pop-nuts does not necessarily indicate that a ground (GND) cable should be installed.
