SIB 51 05 26

GROANING NOISE FROM TAILGATE WHILE CLOSING

E-Series	Model Description
i20	iX Battery Electric Vehicle (from start of production)

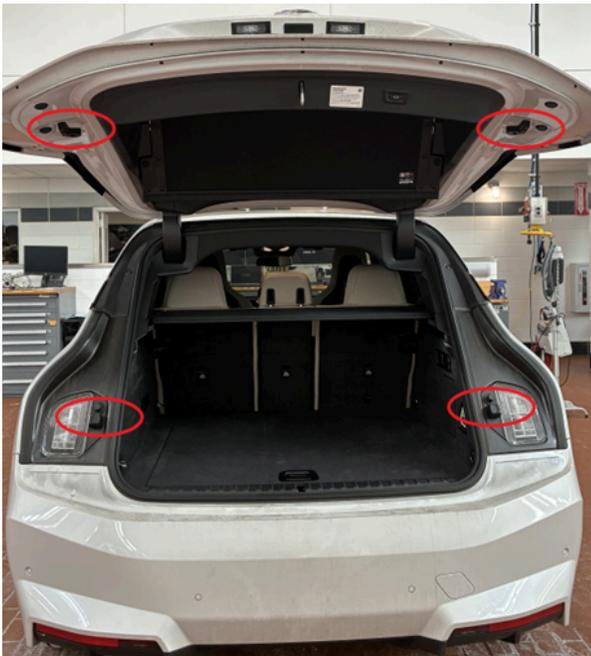
A “groaning” noise may be heard when closing the tailgate.

Contamination of the stop pads and wedges for the tailgate circled in red.

Clean the contamination off the stop pads and wedges for the tailgate.
