SIB 52 01 26

REAR SEAT BACKREST FOR THE 2ND SEAT ROW IS STUCK WHEN FOLDED DOWN

2026-03-09

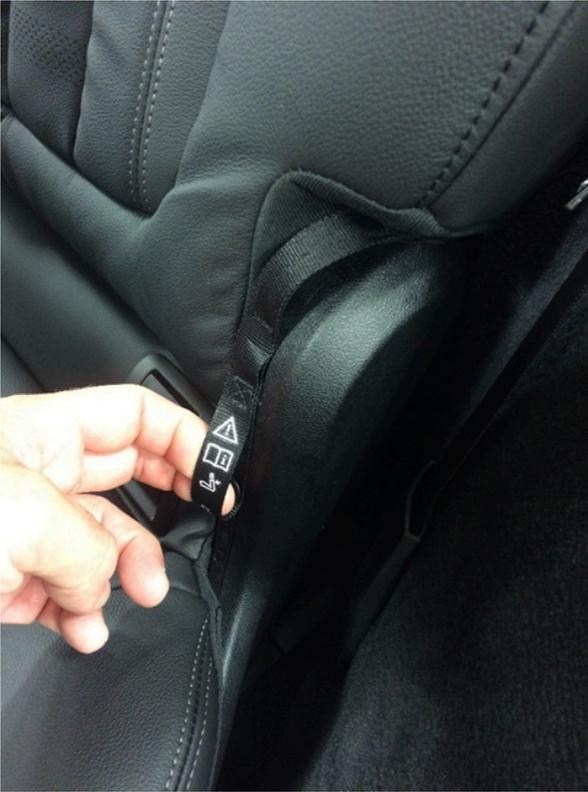
Seat Manual Release 1

The second row 60/40 seat can be manually released in case of electrical failure to access the third-row seats.

This is located at the outer pivot point on each side of the 2nd row seat.

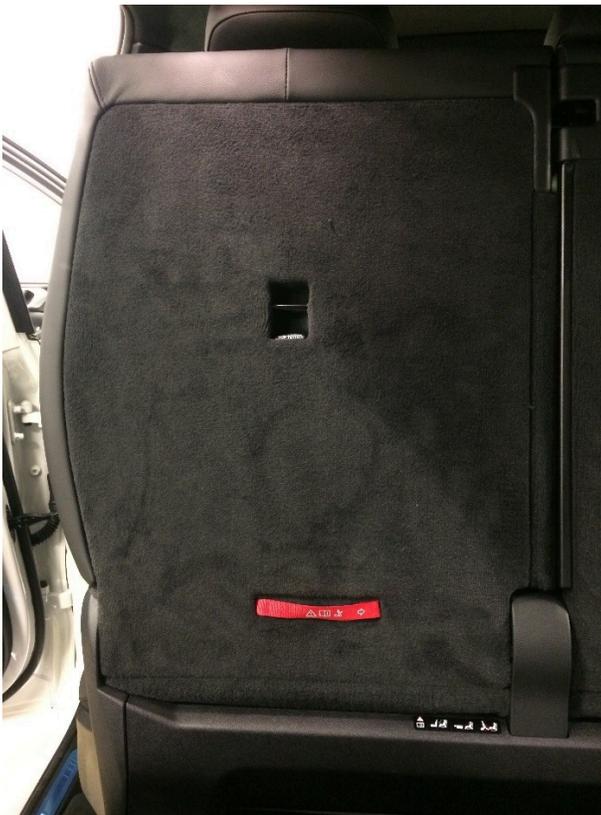
Seat Manual Release 2

The seat release (red) is for the third-row passenger to actuate- folding the second-seat row 60/40 backrest- to allow occupants to exit the vehicle in case of electrical failure.
