GENERAL MOTORS
DCS7454
URGENT - DISTRIBUTE IMMEDIATELY

Subject: N262544790 - Customer Satisfaction Program
Air Compressor Bracket Not Installed

Models: 2025 Chevrolet Silverado Medium Duty

N262544790 Air Compressor Bracket Not Installed

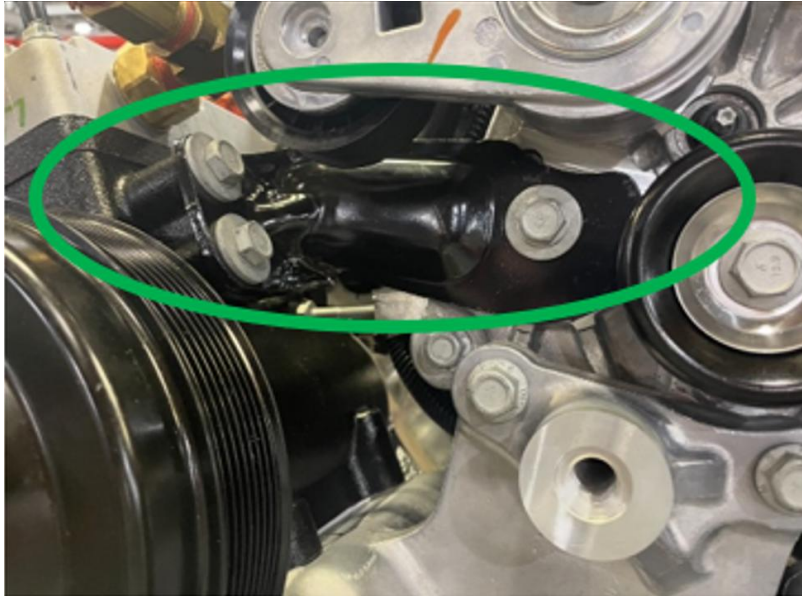
7100462

Condition	Certain vehicles listed above, equipped with Air Compressor Accessory Drive (RPO KUT), may be missing the air compressor bracket.
Correction	Dealers will inspect, and if necessary, install the air compressor bracket.

1. With the hood open, look to the front of the engine and verify the Air Compressor Bracket is installed as pictured. The bracket is located directly under the upper drive belt tensioner. If it is installed, no further action is required.
2. If the Air Compressor Bracket is missing, proceed to the next step.
3. Remove the drive belt tensioner - upper. *Drive Belt Tensioner Replacement – Upper* in SI.
