| HYUNDAI Technical Service Bulletin | GROUP BODY | NUMBER 26-BD-001H |
| | DATE MARCH 2026 | MODEL(S) SANTA FE (MX5A), SANTA FE HYBRID (MX5A HEV) |
| SUBJECT: 2ND ROW CAPTAIN'S CHAIRS ARMREST CAP DETACHMENT | | |

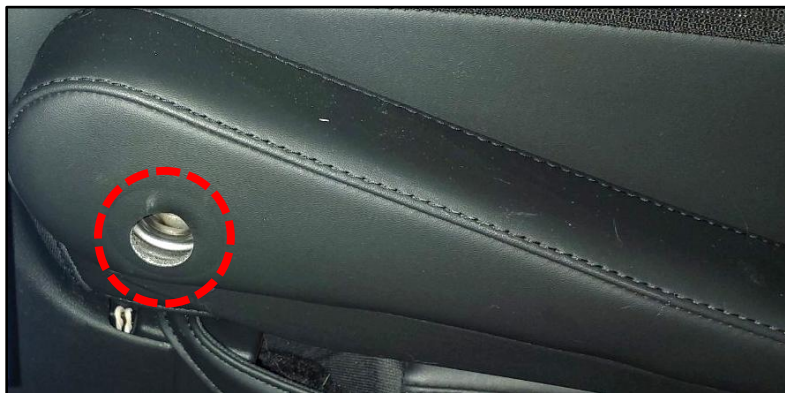
Description: Some Santa Fe (MX5A) and Santa Fe Hybrid (MX5A HEV) vehicles equipped with 2nd row captain's chairs have an armrest cap that may detach. This bulletin provides the procedure to replace the armrest cap on the 2nd row captain's chairs with a revised part.
