Service Bulletin

Bulletin No.: PIT6494A

Subject: Malfunction Indicator Lamp (MIL) DTC P3075- Radiator Inlet Hose Coolant Leak

Brand:	Model:	Model Year:		VIN:		Engine:	Transmission:
		from	to	from	to		
Chevrolet	Colorado	2023-2026		All	All	All	All
GMC	Canyon	2023-2026		All	All	All	All

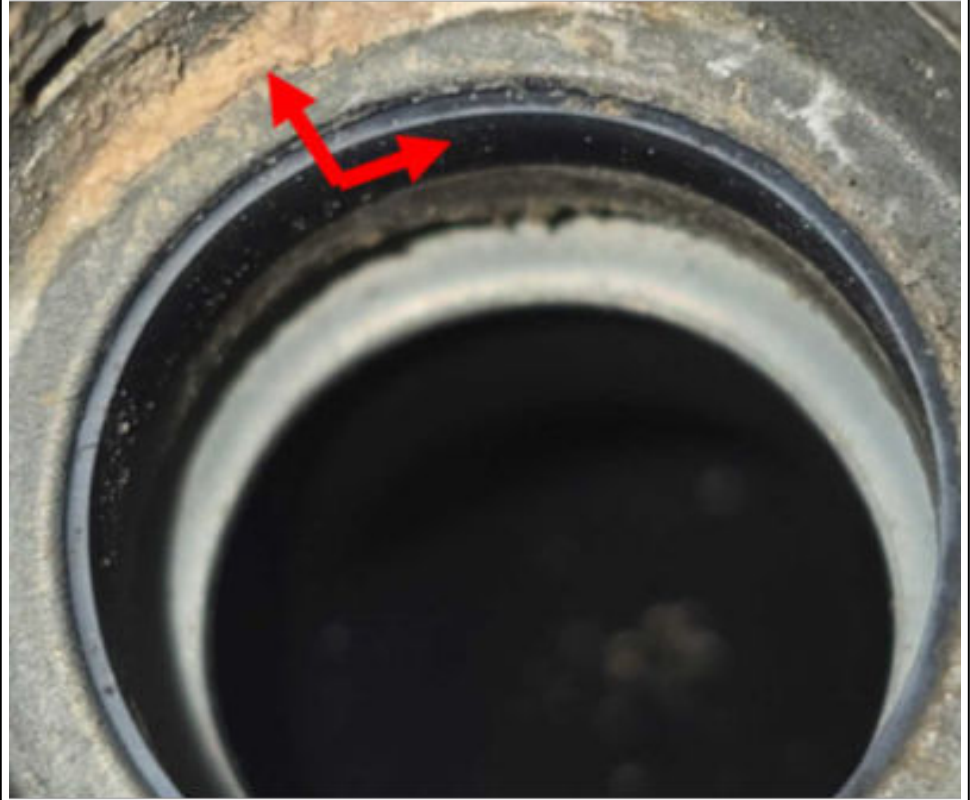
7097960

Involved Region or Country	North America
Condition	<p>Some customers may comment on one or more of the following:</p> <ul style="list-style-type: none"> A visible coolant leak or a low coolant level at the overflow reservoir. The Malfunction Indicator Lamp (MIL) illuminated in the Driver Information Center (DIC). <p>Technicians may observe:</p> <ul style="list-style-type: none"> Coolant leaking from the upper radiator inlet hose connection. DTC P3075 (Engine Coolant Flow Too Low) stored in the Engine Control Module (ECM). <p>Note: In some cases, the condition may be accompanied by DTC P3075.</p> <p>Note: If DTC P3075 is present without evidence of a coolant leak, follow the appropriate Service Information diagnostics.</p>
Cause	<p>The condition may be caused by coolant leakage at the upper radiator hose quickconnect fitting due to a degraded inlethose seal.</p> <p>This leakage originates from the radiator inlet hose seal itself and is not the result of a radiator failure. Seal wear may present with varying levels of residue or buildup depending on vehicle usage and operating environment.</p> <p>Visual inspection of a failed lip seal—typically showing material flattening and residue accumulation around the connection—indicates seal degradation rather than a radiator defect. See Graphic.</p>

1) Drain the cooling system. Refer to Cooling System Draining and Filling in SI.

2) Remove the Radiator Inlet Hose from the vehicle. Refer to Radiator Inlet Hose Replacement. Recommend using a lint-free (clean) cloth to wipe the radiator spigot prior to reassembling the hose to remove any residual contaminate that may be present from the coolant hose. The surface should be smooth and free of contaminate prior to installation of the new hose to prevent leakage.

Important: Do not use any lubricants, grease, or detergents to install the new radiator hose back onto the vehicle.
