## Rearview Camera Noise Optimization

Topic number	LI54.71-P-080180
Version	4
Function group	54.71 - Camera and radar-assisted assistance systems
Date	3/16/26
Validity	167 Facelift (GLE) with the following:  - Model Year 2024 and later (Option code 804, 805, or 806)  - Option Code 491 (Steel Spring Variant)  - Option Code 235 (PARKTRONIC with Active Parking Assist)
Reason for change	Adding Model Year 2026

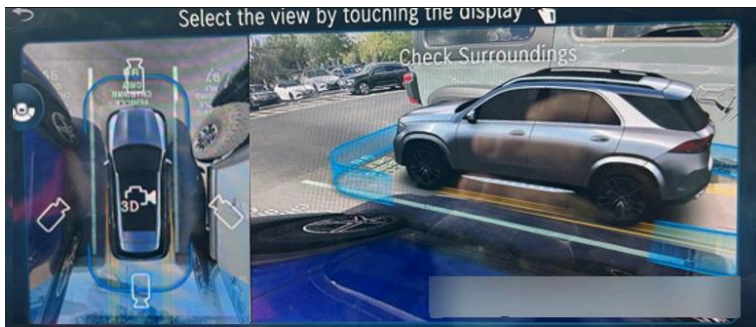
View PRIOR to SCN Coding:

- 1) The "3D" icon when in the top down vehicle view, will no longer be present on the head unit.
- 2) The digital rendering of the vehicle with the ability to spatially move around the vehicle is no longer possible. This view is replaced with 2D static images of the left and right sides.
