Subject: Update to February 25, 2026 Letter Regarding Ballard Fuel Cell External Coolant Leak

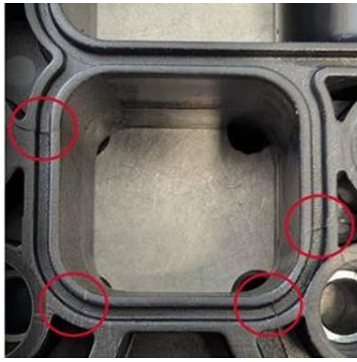
- Returned parts to Ballard exhibited tooling flash on the manifold. This tooling flash is located within the manifold channel where the gasket seats.
- Excess volume of webbing on the gasket creates a hydraulic locking condition where the manifold does not have space for expansion in the corners of the gasket creating a “squeeze out” condition of the EPDM.
- The gasket squared profile presents a configuration in which, under certain conditions, the EPDM gasket volume may approach the limits of the available channel space depending upon assembly conditions.

Red circles indicate areas of tooling flash on the manifold

Through a combination of removing the tooling flash from the manifold and reworking the EPDM gaskets to remove excess material in the corners of the gasket, we have been successful in eliminating the leak. This has been verified on over 30 buses.

As a permanent corrective action, Ballard has utilized existing certified tooling to produce parts with refined profiles that improve channel fit. The updated design incorporates webbing that supports controlled gasket expansion in the manifold corners. These parts were produced in silicone based on the tooling already available for this material. Ballard is also ensuring the manifolds do not have the tooling flash.

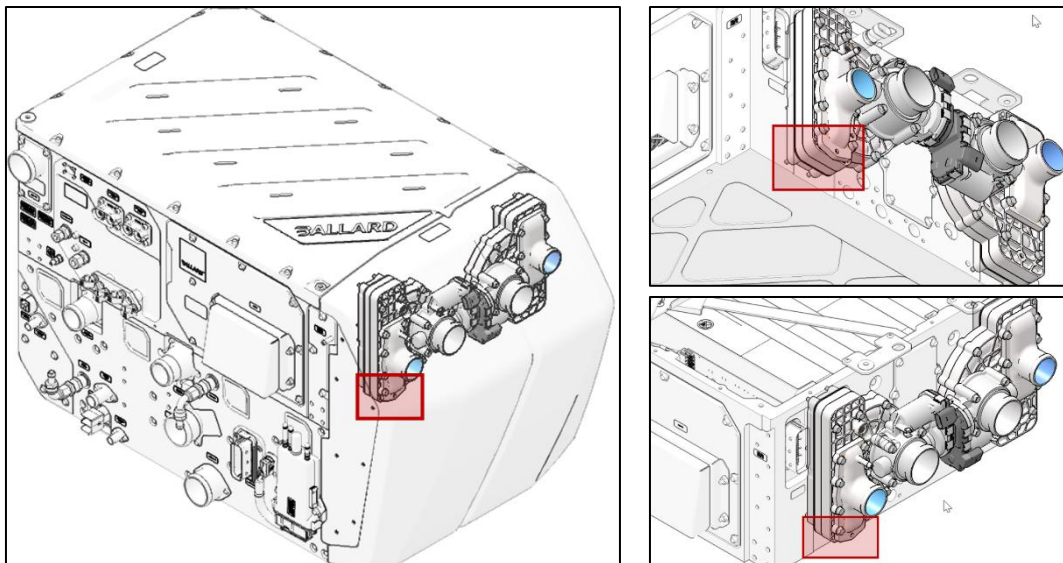
As was previously shared, during a routine inspection, a New Flyer team member observed liquid beneath a Ballard hydrogen fuel cell installed on a bus. Ballard subsequently confirmed that the liquid was coolant. Following this observation, additional inspections at the Anniston facility identified similar instances on a limited number of buses, typically involving small droplets sometimes collecting below the fuel cell. In these cases, approximately 250–300 ml of coolant was observed to have escaped from the manifold inlet port, an area subject to higher inlet-side pressures.

While campaign logistics are being finalized, customers should continue to follow their standard preventive maintenance practices, including routine inspections for coolant leaks. The below pictures (shaded area specifically) identify the area where these coolant leaks have been found.

Both New Flyer's standard 6,000-mile inspection interval and Ballard's three-month inspection interval include coolant leak inspection as a normal maintenance item. If a coolant leak is identified during regular inspections, customers are encouraged to contact their New Flyer representative or Ballard directly so that a repair can be coordinated in advance of the broader upgrade campaign. If no coolant leak is identified, no further action is required and bus can be returned to revenue service.
