**Diagnostic Sheet**

# Grecale - Engine Bay Wiring Harness Diagnosis

DATE: March 11, 2026

**MODELS AFFECTED:** (M182) Grecale – All MY**ANOMALY:**

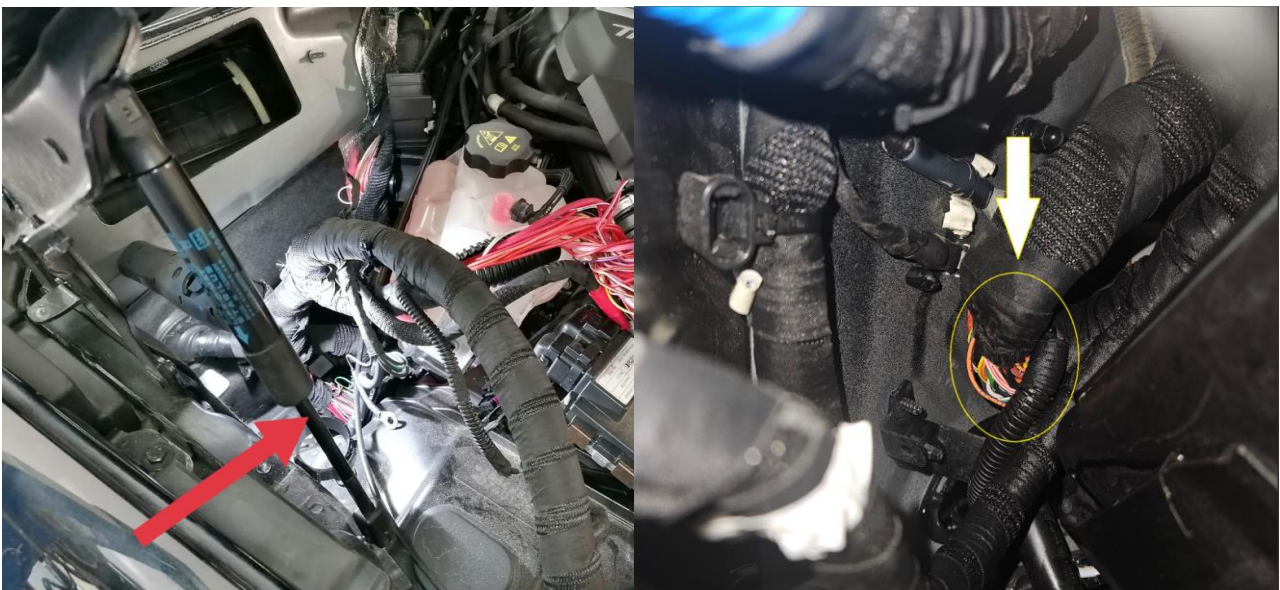
Once access is available, inspect the wiring harness directly beneath the FDU.

Pay close attention to the **section of wiring with no tape wrapping**, as this area is more likely to show signs of wear, contact, or damage.
