TECHNICAL SERVICE BULLETIN

26-2102

Illuminated Yellow/Red ABS Warning Indicator With DTCs C0037:01, C0037:07, C0037:2F, C0037:4A, C0037:64, C003A:01, C003A:07, C003A:2F, C003A:4A, And/Or C003A:64 Stored In The ABS Module

Ford 2025 Mustang GTD	Built on or before 14-Aug-2025
--------------------------	--------------------------------

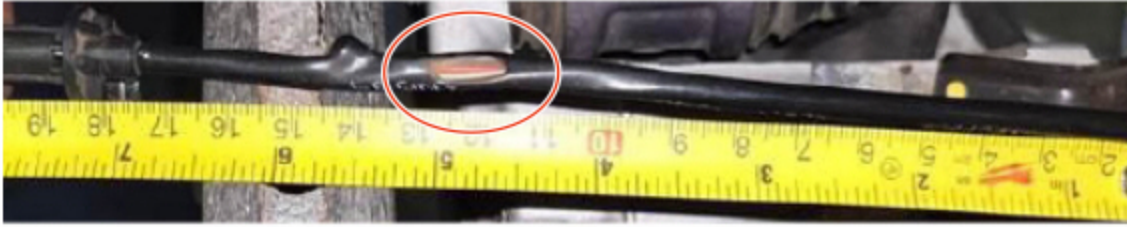
Figure 1

Issue: Some of the vehicles listed in the Model statement above may exhibit an illuminated yellow/red ABS warning indicator with DTCs C0037:01, C0037:07, C0037:2F, C0037:4A, C0037:64, C003A:01, C003A:07, C003A:2F, C003A:4A, and/or C003A:64 stored in the ABS module. This may be due to thermal damage in the heat shield that covers the rear wheel speed sensor wire harness, caused by the heat generated from the rear brake rotors.

1. Does the rear wheel speed sensor(s) show signs of thermal damage similar to those in Figures 1-2?

2. Replace the affected rear wheel speed sensor(s) with the new, updated part. Refer to WSM, Section 206-09 Anti-Lock Brake System (ABS) and Stability Control > Removal and Installation.
