TECHNICAL SERVICE BULLETIN

Sharp-Angled Contour At The Bottom Rear Edge Of The Front Door(s)

26-2110

Ford 2025 Expedition
Lincoln 2025 Navigator

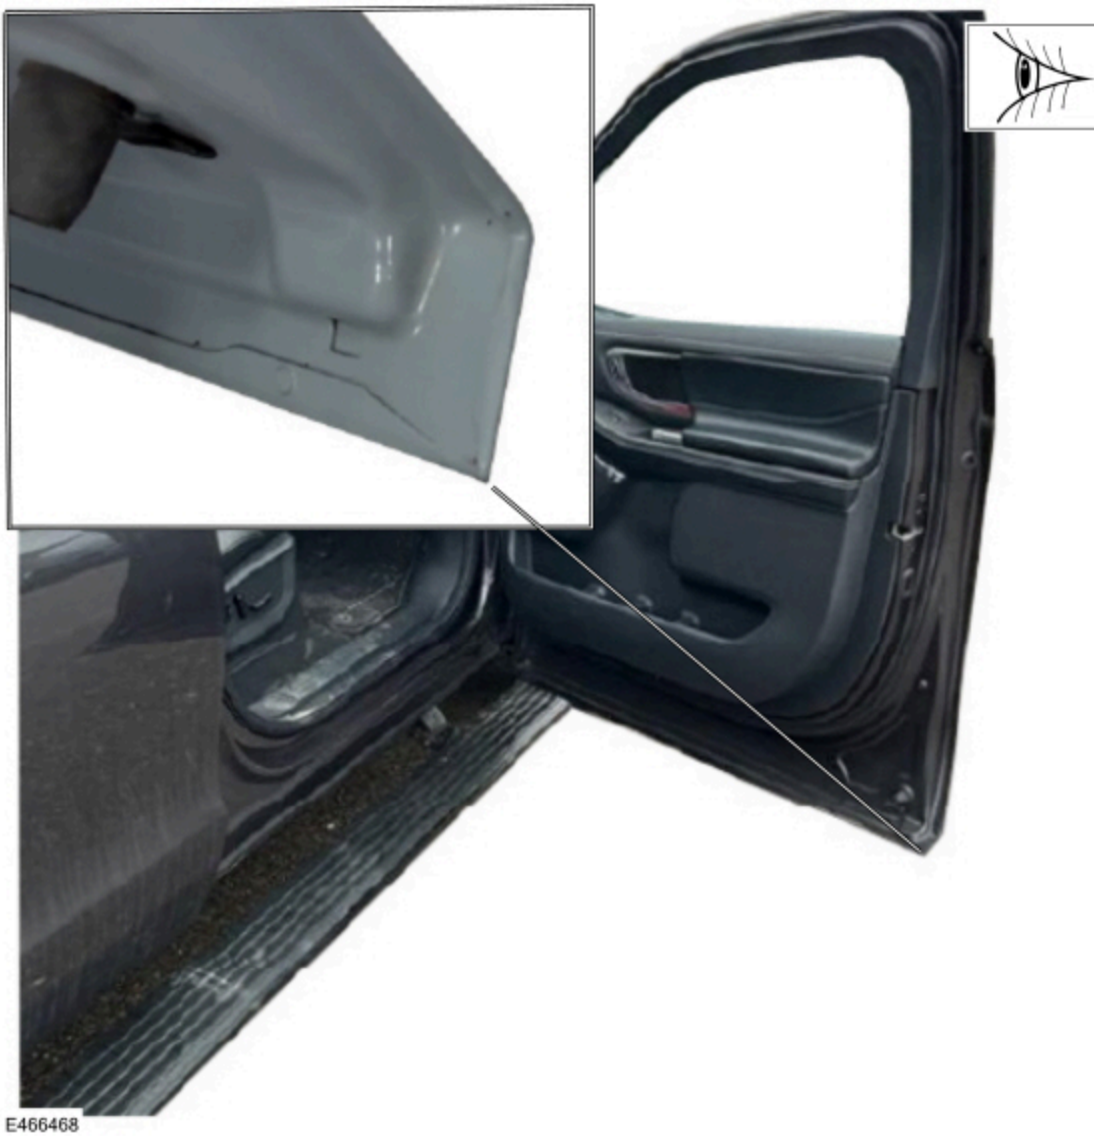
Figure 1

Issue: Some of the vehicles listed in the Model statement above may exhibit a sharp-angled contour at the bottom rear edge of the front door(s). This bulletin describes the procedure to repair the condition.

1. Open both front doors and inspect for a sharp-angled contour at the bottom rear edge of the front door as shown in Figure 1. Does either front door exhibit a sharp-angled contour as shown in Figure 1?

Action: For vehicles that meet all of the criteria in the Issue and Model Statements, follow the Service Procedure to round off the sharp-angled edge and touch up the paint on the affected area of the front door(s)
