REFERENCE:	TSB: 23-007-26 GROUP: 23 - Body	Date:	March 12, 2026	REVISION:	—
VEHICLES AFFECTED:	2019 - 2022 (DT) RAM 1500 Pickup This bulletin applies to vehicles built on or after August 01, 2018 (MDH 0801XX) and on or before July 25, 2022 (MDH 0725XX).			MARKET APPLICABILITY: <input checked="" type="checkbox"/> NA <input type="checkbox"/> CH <input type="checkbox"/> EE <input type="checkbox"/> IAP <input type="checkbox"/> SA <input type="checkbox"/> MEA NOTE: This bulletin applies to the North American markets.	
CUSTOMER SYMPTOM:	Customers may comment on the following: <ul style="list-style-type: none"> Wrinkles or bubbles in the instrument panel cover Fig. 1. 				
CAUSE:	Manufacturing defect

This Technical Service Bulletin (TSB) has also been released as a Rapid Service Update (RSU) 26-048 date of issue March 12, 2026.

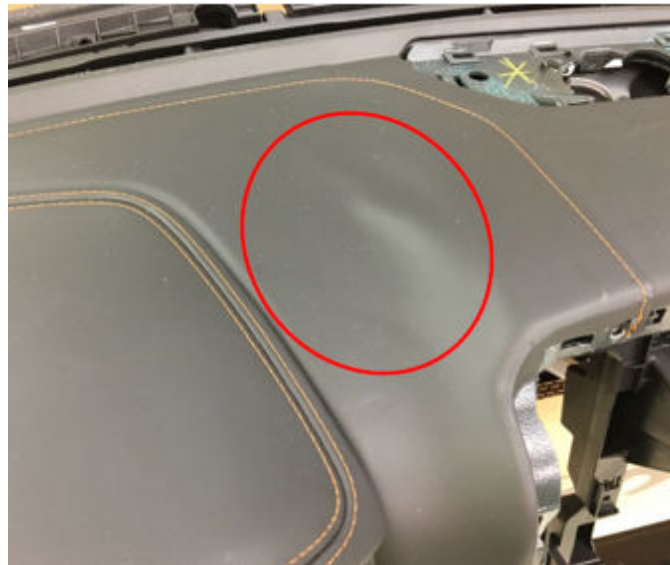
Fig. 1
Wrinkles Or Bubbles In The instrument Panel Cover

This bulletin replacing the instrument panel cover.

1. Replace the instrument panel cover. Refer to the detailed procedures available in DealerCONNECT > Service Library> under: 23 - Body / Instrument Panel / Cover, Instrument Panel / Removal and Installation.
