Service Bulletin

Bulletin No.: PIT6473D

Subject: Service Forward Collision / Forward Collision Unavailable Messages / Automatic High Beams Inop / Camera Only Learns to 94% / U3000

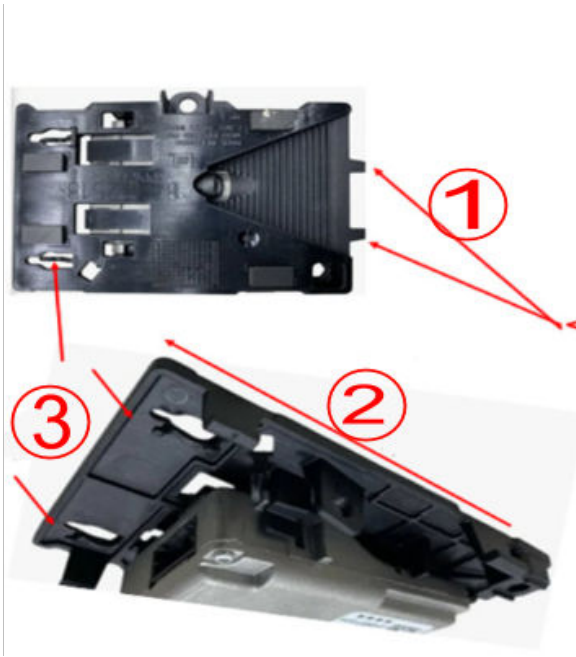
7050857

- 1) Alignment tabs
- 2) Push in direction of arrow to release lift tabs
- 3) Lift tabs

STEP 2. Remove B174W FVCM brackets from interior windshield (refer to pictures below).

STEP 8. Reinstall the FVCM bracket, FVCM, mirror and trim. (review and inspect the FVCM tabs to ensure they are properly seated).
