# Service Bulletin

Bulletin No.: PIT6473C

**Subject: Service Forward Collision / Forward Collision Unavailable Messages / Automatic High Beams Inop / Camera Only Learns to 94% / U3000**

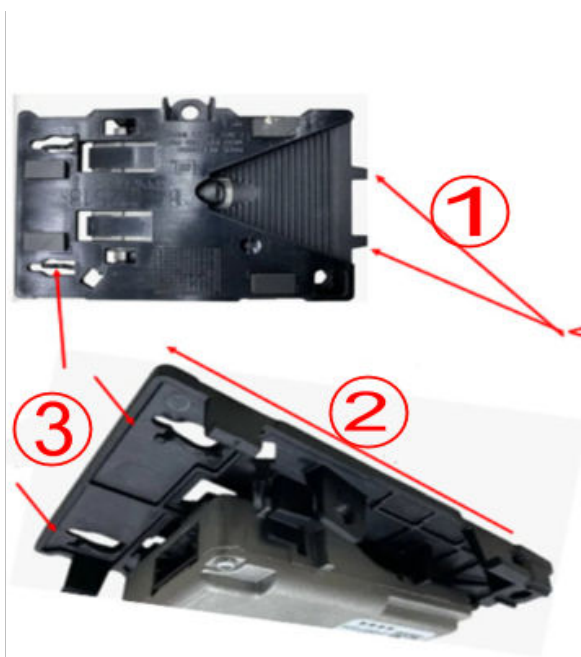
7050857

- 1) Alignment tabs
- 2) Push in direction of arrow to release lift tabs
- 3) Lift tabs

STEP 2. Remove B174W FVCM brackets from interior windshield (refer to pictures below).

STEP 8. Reinstall the FVCM bracket, FVCM, mirror and trim. (review and inspect the FVCM tabs to ensure they are properly seated).
