## Field Campaign (Low Priority)

### Modification Bulletin

# 40-0053 - MB - EUR/US - YTxx3 DOT - CAM0196 replacement relay K03 12V

**Replacement relay K03 12V  
YTxx3 DOT**

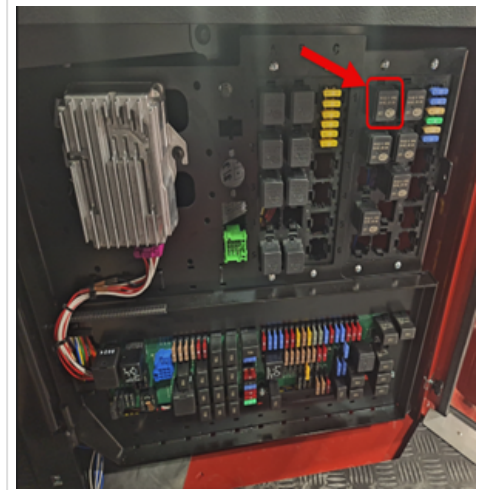
figure 3, position of K03 12V

4. Check on the rear side of the relay block whether relay K03-12V is installed in the correct position, based on the existing relay label. The wires running to the relay block should indicate K03-12V (see figures 3, 4 and 5)

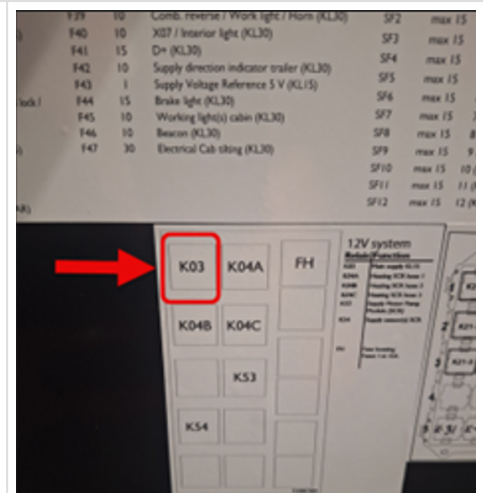
figure 5, compare position in real life with label

It was found that a wrong relay was installed in the starting circuit of the engine for the YT DOT vehicles. The relay switches a 12 volt circuit, but is operated via 24 volt. Currently a 12 volt relay is installed. Over time this relay can fail due to the applied current on the coil being too high. This can result in failure of the relay, and cause a malfunction during the starting attempt of the engine.

5. Remove the current relay from the K03-12V position. See figure 5.

6. Install relay t25035235 in the K03 -12V position.
