Clicking Sound While Turning the Steering Wheel

Year	Model	Trim Level
2023 and later	Accord	ALL

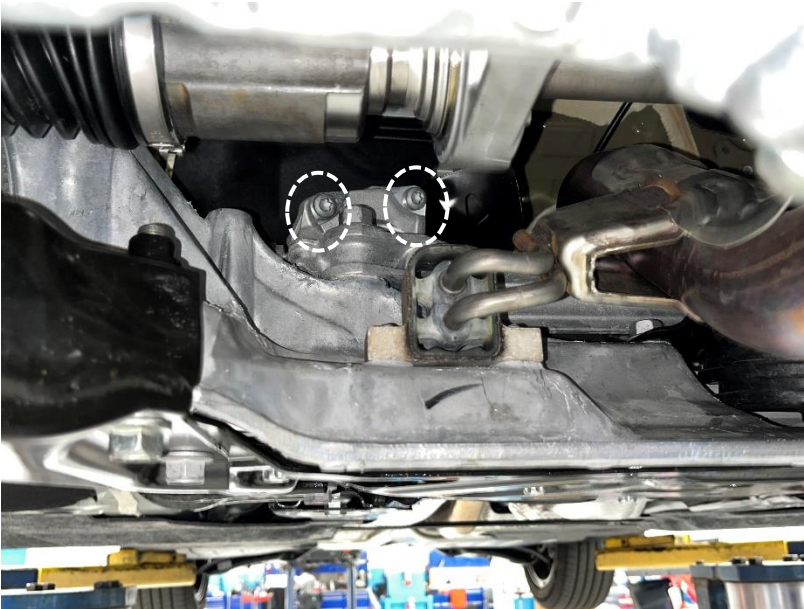
Lack of sufficient clearance between the steering gearbox motor housing and the steering rack.

2. From the front of the vehicle, loosen the two bolts holding the steering gearbox motor housing.
