<b>REFERENCE:</b>	<b>TSB:</b> 08-011-26 REV. A <b>GROUP:</b> 08 - Electrical	<b>Date:</b>	March 17, 2026	<b>REVISION:</b>	08-011-26
<b>VEHICLES AFFECTED:</b>	<b>2025 (WL) Jeep Grand Cherokee / Grand Cherokee L</b> This bulletin applies to vehicles equipped with a Global Telematics Box Module (Sales Code RDG).		<b>MARKET APPLICABILITY:</b> <input checked="" type="checkbox"/> NA <input type="checkbox"/> MEA <input type="checkbox"/> SA <input type="checkbox"/> IAP <input type="checkbox"/> EE <input type="checkbox"/> CH <b>NOTE:</b> This bulletin applies to the North America market.		
<b>CUSTOMER SYMPTOM:</b>	<p><b>Customers must experience a Malfunction Indicator Lamp (MIL) illumination and the vehicle must exhibit/set one or more of the following Diagnostic Trouble Codes (DTCs):</b></p> <ul style="list-style-type: none"> <li>• <b>**B1562-14 - GPS Antenna-Circuit Short To Ground Or Open.</b></li> <li>• B1561-11 - Cellular Antenna 2-Circuit Short To Ground.</li> <li>• B1560-11 - Cellular Antenna 1-Circuit Short To Ground.**</li> <li>• B22A9-96 - ECU Internal Performance-Component Internal Failure.</li> <li>• B1560-13 - Cellular Antenna 1-Circuit Open.</li> <li>• B1561-13 - Cellular Ant

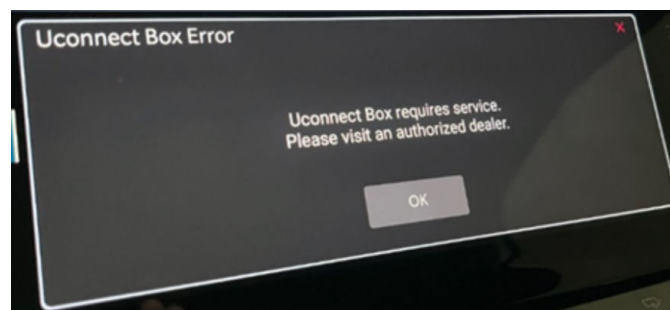
<b>CAUSE:</b>	TBM Software

**Fig. 1**  
Uconnect Box Requires Service

**NOTE:** This message can be triggered by different reasons **Fig. 1**. For an issue on a new vehicle recently switched to customer mode, please follow the New Vehicle Preparation procedure to resolve the issue. For the customer vehicle with intermittent concerns, please check the TBM, antenna and instrument panel harness connections.

This bulletin involves reprogramming the TBM with the latest available software.

1. Reprogram the TBM with the latest software. If issues arise when flashing a module using the wiTECH Diagnostic Application, please submit a ticket to the Helpdesk. The helpdesk can be found within the Help menu.
2. Clear all DTCs that may have been set in any module due to reprogramming. The wiTECH application will automatically present all DTCs after the flash and allow them to be cleared.
