## STAR ONLINE PUBLICATION

**Case Number:** S2219000004 Rev. A

**Models Affected:** 2022-2026 Jeep Wagoneer (WS).

**Symptom/Vehicle Issue:** Service Electric Power Steering Message On Cluster.  
C0051-54 Steering Wheel Position Sensor Calibration, C0051-64 Steering Angle Set.

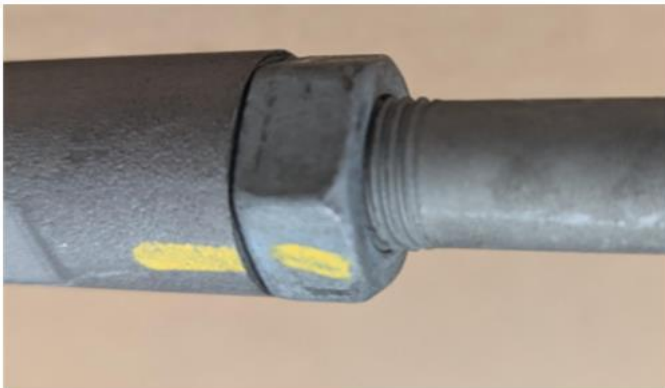
**<<<Note>>>** This condition may have happened during service work or possibly a minor collision like wheel contact with a curb. A visual symptom of the issue could be the tie rod adjusters exhibit uneven exposed thread count as shown below (Fig 1 and Fig 2). If this exists- continue with the below inspection.

Left and Right Outer Tie Rod Adjustment Uneven Thread Count.

3. If the tie rod adjusters have a significant visual difference in exposed threads (Fig 1, Fig 2) perform a toe alignment and verify the steering wheel position is straight.
4. Install the driver air bag and any trim removed prior.
5. Test drive the vehicle to confirm customer complaint is resolved.
