GENERAL MOTORS
DCS7458
URGENT - DISTRIBUTE IMMEDIATELY

Subject: REVISION: N252528650-01– Service Update
Body Seal Water Leak
Revised Parts Table

Models: 2024-2025 Chevrolet Equinox EV

N252528650 Body Seal Water Leak

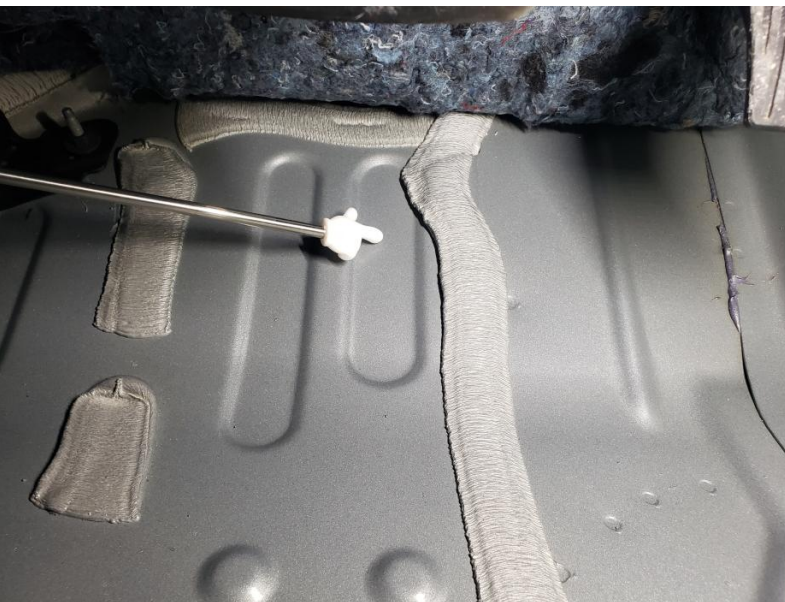
7080803

7. Inspect the seam sealer in the driver side footwell for any signs of water intrusion. If water intrusion or moisture damage is found originating at the point indicated above, proceed to Seam Sealer Repair below. If water is entering the vehicle from any location other than as shown above, contact GM Technical Assistance Center to provide information on location of water found. GM Technical Assistance Center must only be contacted for driver's side concerns. If directed, refer to Seam Sealer Repair below.

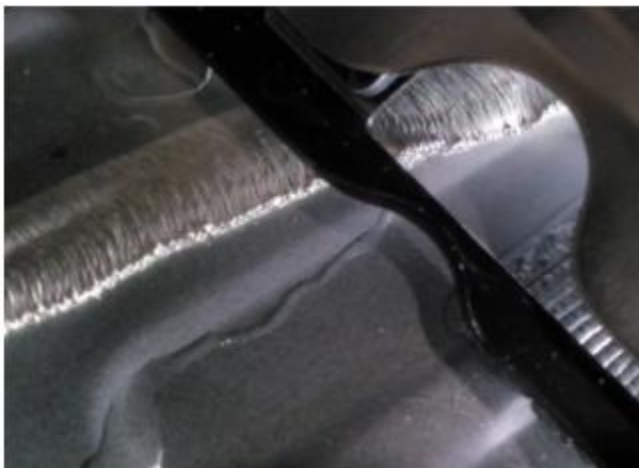
7002662

13. Inspect the seam sealer in the passenger side footwell for any gaps or signs of water intrusion. If **ANY** gap or sign of water intrusion is found, refer to *Seam Sealer Repair* below.
14. If signs of water intrusion are not present: reassemble the passenger side carpet and trim, no further action is required.

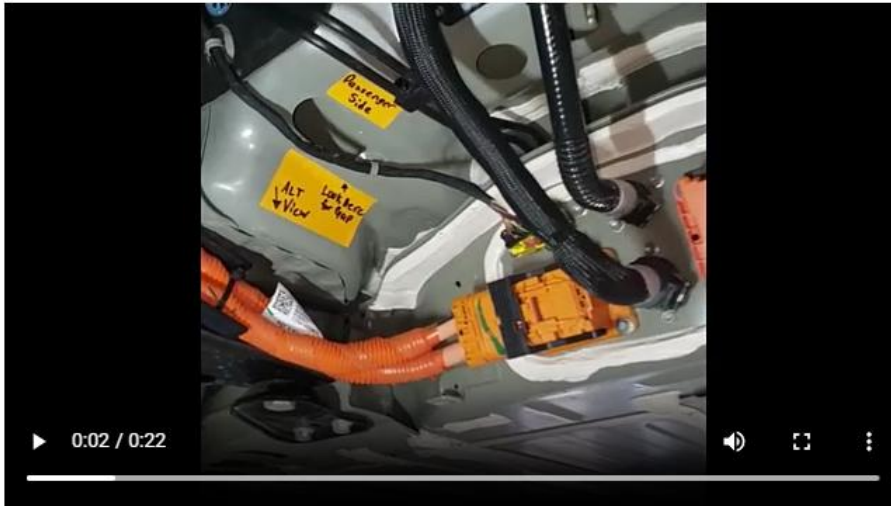
7002730

Note: Passenger side shown above, Driver's side has the same access.

3. Confirm the leak by applying water to the seam shown above on the appropriate driver or passenger side. After spraying, lower the vehicle and check for water inside the appropriate footwell.
4. After confirming, raise the vehicle again and use compressed air to blow all the water out of the affected area. It must be DRY before applying seam sealer.
