Transmission Shift Stalk

TSB-26-058-FTL

- ▶ New Cascadia
- ▶ Business Class M2-Plus
- ▶ 108SD Plus/114SD Plus

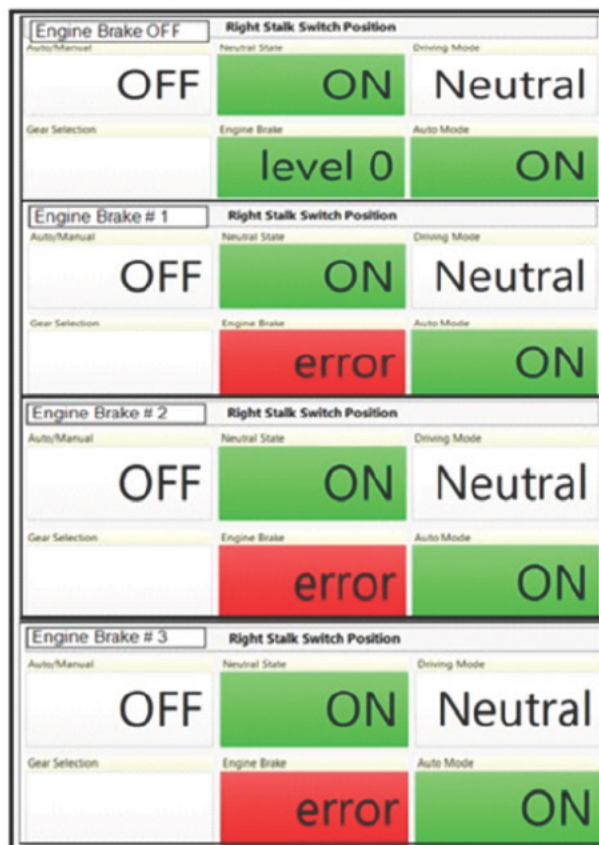
Fig. 1, Shift Stalk Position Panel on DiagnosticLink

- Park the vehicle on a level surface, shut down the engine, and set the parking brake. Chock the tires.
- Confirm the right-hand shift stalk is swept all the way counterclockwise, ensuring the engine brake is OFF. For detailed information on the engine brake operation, see the applicable drivers manual.
- Connect the vehicle to DiagnosticLink®.
- Turn the keyswitch to the ON position.
- Expand the Computer Programming Control (CPC) dropdown and open the 'Right Stalk Switch Position' panel.
- Sweep the shift stalk clockwise to each brake position and inspect the engine brake level reading. Stalk switches experiencing this issue display 'error' in place of an engine brake level (1 to 3). See Fig. 1.

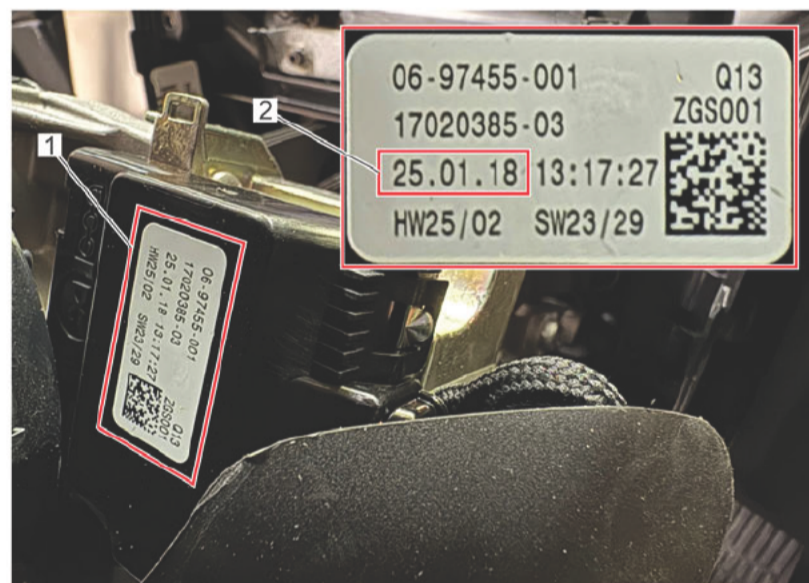
Fig. 2, Manufacturer's Label

8. Inspect the manufacturer's label on the right-hand stalk switch, and verify if the build date is within the affected range from January 1, 2024 (24.01.01), through August 31, 2024 (24.08.31). See Fig. 2.

1. Manufacturer's Label on the Stalk Switch

2. Build Date - January 18, 2025, Clarify this build date is not included in the population

9. If the part number, symptoms, and date code criteria are met, then replace the part. If not, use the previously published diagnostic information based on the complaint to continue investigating.
