247 (GLA/GLB) with 235 & 501 - Rearview Camera Noise Optimization

Topic number	LI54.71-P-080349
Version	1
Function group	54.71 - Camera and radar-assisted assistance systems
Date	3/25/26
Validity	247 (GLA & GLB) with all of the following: <ul style="list-style-type: none">- Model Year 2024 and later (Option code 804, 805, 806, etc...)- Option code 459 or 485 (Steel spring variants)- Option code 235 AND 501 (PARKTRONIC with Active Parking Assist)
Reason for change

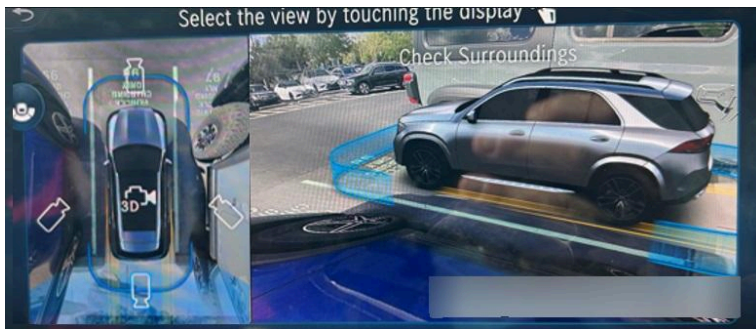
View PRIOR to SCN Coding:

IMPORTANT: After both control units have been SCN coded, the "Movable 3D View" feature in the head unit will no longer be available. With this change there will be two distinct differences:

- 1) The "3D" icon when in the top down vehicle view, will no longer be present on the head unit.
- 2) The digital rendering of the vehicle with the ability to spatially move around the vehicle is no longer possible. This view is replaced with 2D static images of the left and right sides.
