## 247 (GLA/GLB) with 235 & 501 - Rearview Camera Noise Optimization

Topic number	LI54.71-P-080349
Version	2
Function group	54.71 - Camera and radar-assisted assistance systems
Date	3/27/26
Validity	247 (GLA & GLB) with all of the following:  - Model Year 2024 and later (Option code 804, 805, 806, etc...)  - Option code 459 or 485 (Steel spring variants)  - Option code 235 AND 501 (PARKTRONIC with Active Parking Assist)
Reason for change	Updating language

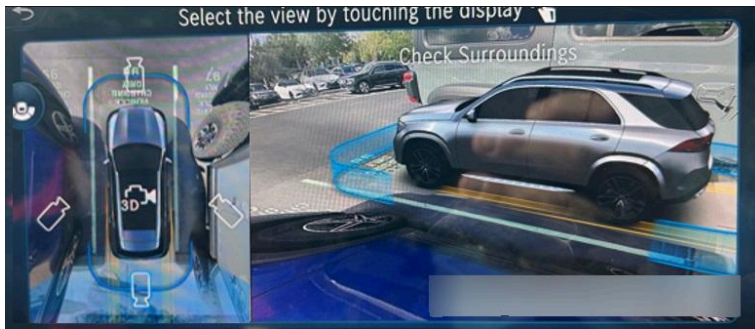
View PRIOR to SCN Coding:

IMPORTANT: After both control units have been SCN coded, the "Movable 3D View" feature in the head unit will no longer be available. With this change there will be two distinct differences:

- 1) The "3D" icon when in the top down vehicle view, will no longer be present on the head unit.
- 2) The digital rendering of the vehicle with the ability to spatially move around the vehicle is no longer possible. This view is replaced with 2D static images of the left and right sides.
