SIB 51 22 24

MAIN DOOR SEAL DETACHING AT THE SEALING JOINT

2026-03-18

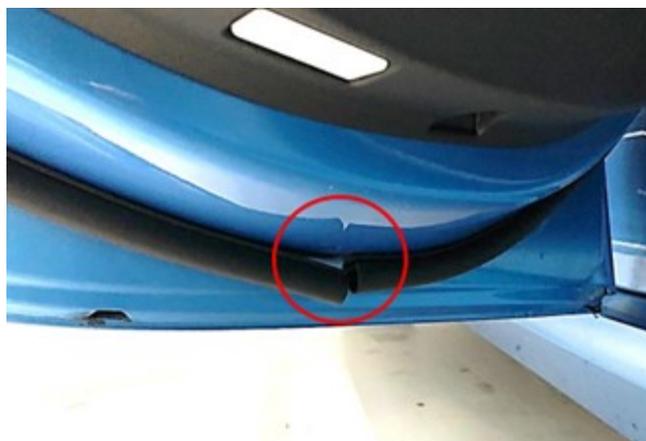
On the main door seal, detachment behavior can be detected at the **sealing joint**.

Over time, the seal gradually and increasingly detaches which can cause it to-

- Dangle
- Become visible to the customer
- Prevent the door from closing properly

Contamination of the surface onto which the door seal bonds/adheres.

Partially replace the affected main door seal.

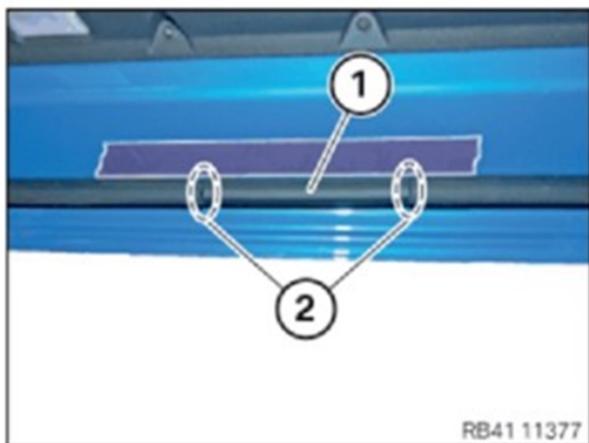
1. Verifying the customer's concern as the issue.

2. For cases where the main door seal detaches in an area not visible to the customer (see illustration above), repair the detached portion by replacing the affected section following the repair instructions in ISTA/AIR 51 71 003.

Note: When replacing the damage section, please ensure the repair does not extend toward the door lock area. It is acceptable to extend toward the door hinge side, as this keeps the repair concealed from the customer's view.
