SIB 61 05 26

WASHER PUMP STRAINER LEAKING

2026-03-20

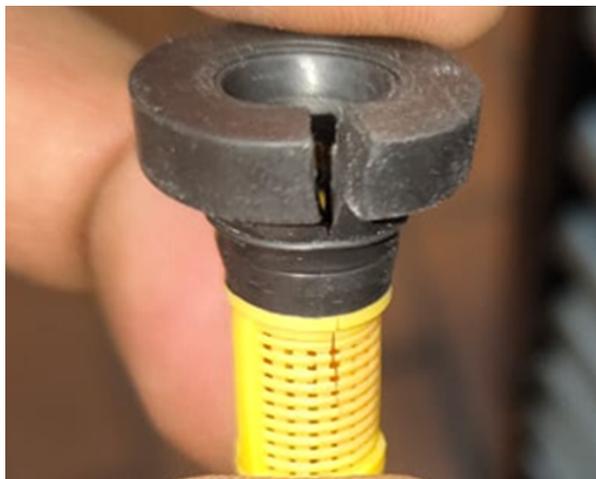
The top rubber ring on the washer pump's filter may be torn.

This can occur when the pump's filter is placed first on the washer fluid pump before being installed in the reservoir.

Such leaks can result in fluid loss and may affect the proper functioning of the washer system.

Replace the washer pump strainer(s) that are leaking with the updated part **(61 66 5 B83 629)**.
