SIB 63 07 25

CHECK CONTROL MESSAGE (CCM) PRESENT FOR THE TAILLAMPS

2026-03-17

E-Series	Model Description	Production Date
F74	2 Series Gran Coupe	From November, 2024
F95	X5 M Sports Activity Vehicle	From March 31, 2023 - Onward
G05	X5 Sports Activity Vehicle	"

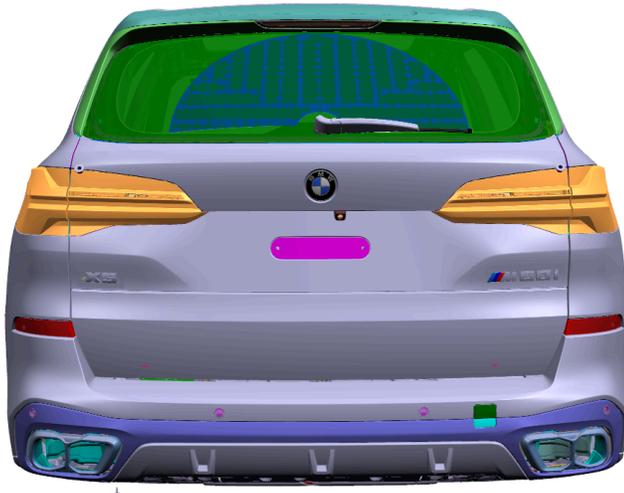
The check control message(s) for the **(brake lights, taillights, side lights, turn indicator, daytime driving lights)** taillamps (highlighted in orange in the photo) is intermittently displayed.

Software error in the RLMAL, RLMAR, RLML, RLMIR (inner and outer taillamps).

Software update of the RLMAL, RLMAR, RLML, RLMIR.
