SIB 63 09 25

FAILURE/MALFUNCTION OF THE AMBIENT LIGHTING

2026-03-18

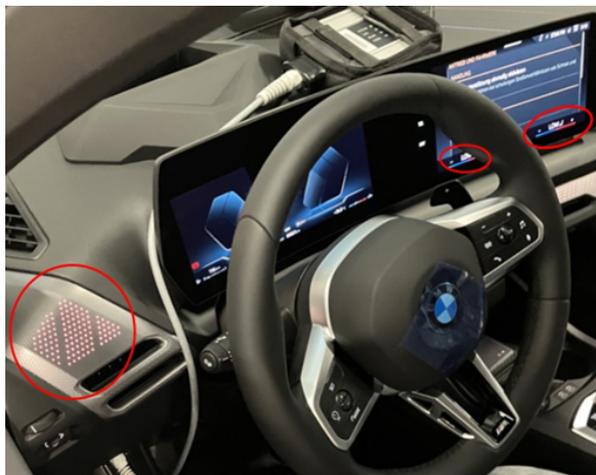
After programming the vehicle via ISTA/RSU to 25-07-5xx, some of the interior ambient lighting strips (examples circled) may no longer function properly.

Possible fault codes entries for F74:

- **804A38 – Interior lights layering (IL-LIN_3): versioning incorrect: LIN slave 5**
- **804A39 – Interior lights layering (IL-LIN_3): versioning incorrect: LIN slave 6**
- **804A3E – Interior lights layering (IL-LIN_3): versioning incorrect: LIN slave 11**

Unfavorable logic in the LED control unit hub.

Follow the test plan to encode the LED control unit hub.

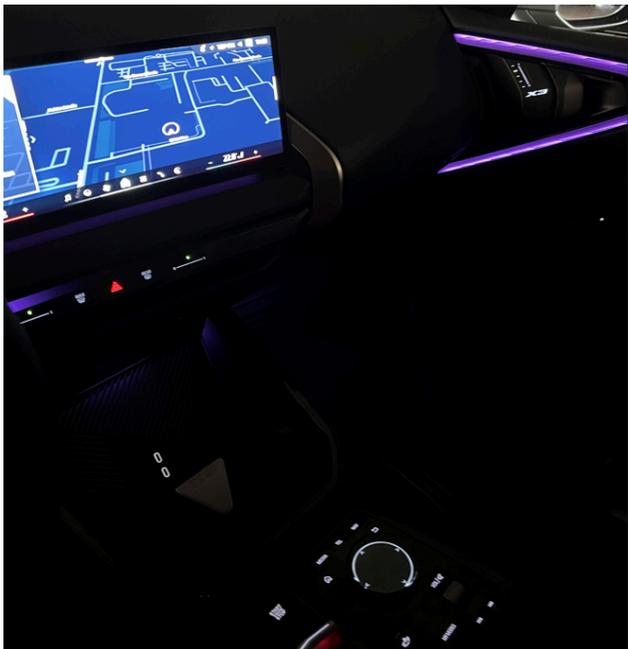
Possible fault codes entries for G45:

- **804A34 – Interior lights layering (IL-LIN_3): versioning incorrect: LIN slave 1**
- **804A35 - Interior lights layering (IL-LIN_3): versioning incorrect: LIN slave 2**
- **804A36 - Interior lights layering (IL-LIN_3): versioning incorrect: LIN slave 3**
- **804A37 - Interior lights layering (IL-LIN_3): versioning incorrect: LIN slave 4**
- **804A38 - Interior lights layering (IL-LIN_3): versioning incorrect: LIN slave 5**
- **804A3A - Interior lights layering (IL-LIN_3): versioning incorrect: LIN slave 7**
- **804A47 - Interior lights layering (IL-LIN_3): versioning incorrect: LIN slave 8**
- **804A48 - Interior lights layering (IL-LIN_3): versioning incorrect: LIN slave 9**
