SIB 65 04 26

ALARM SYSTEM MALFUNCTIONING (CONVERTIBLES)

2026-03-16

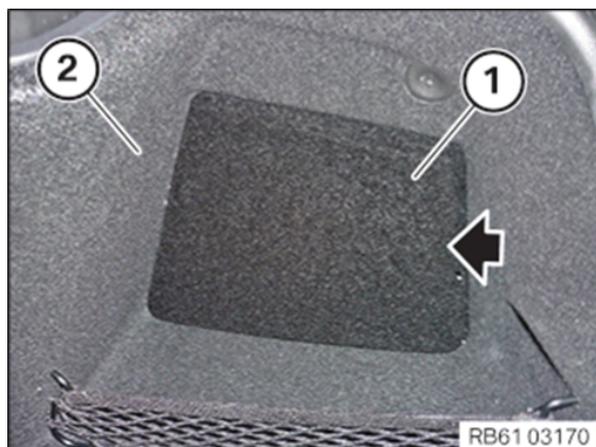
1. Remove the flap (1) from the luggage compartment wheel arch trim panel at right (2).
