SIB 65 07 26

“STORAGE SPACE RUNNING OUT” MESSAGE APPEARS – HU-H6

2026-03-17

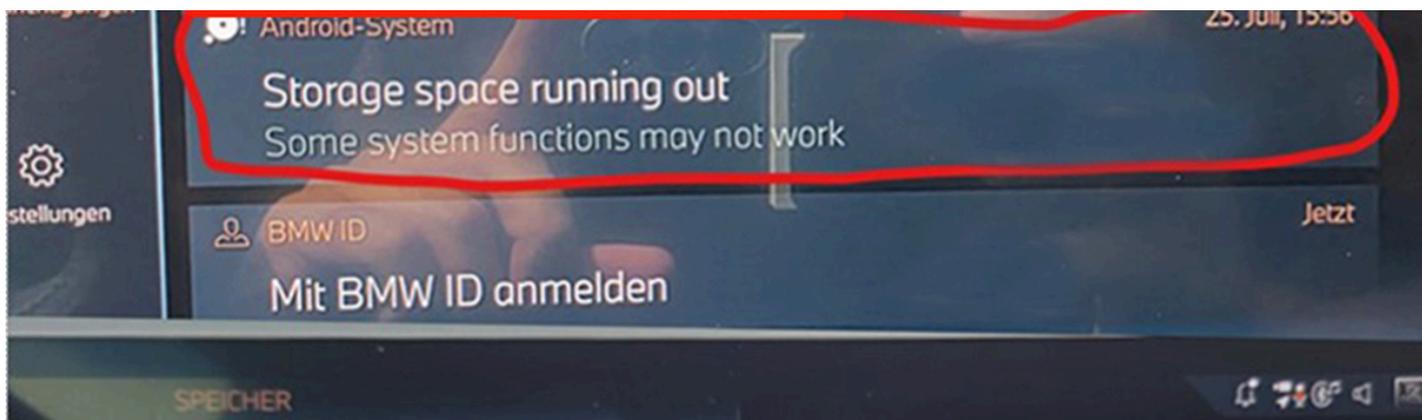
The following message is displayed on the central information display (CID): “Storage space running out”. Afterwards, apps can no longer be updated, and additional content can no longer be loaded.

Unfavorable software in the head unit (HU-H6) causes an incorrect memory setting on head unit (HU-H6) start-up.

Reset the head unit (HU-H6) to factory settings.

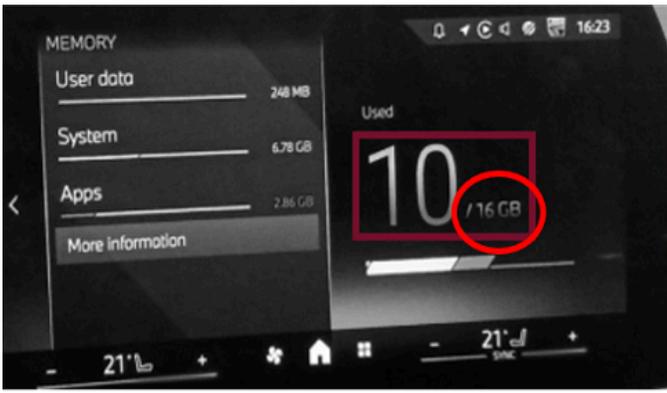
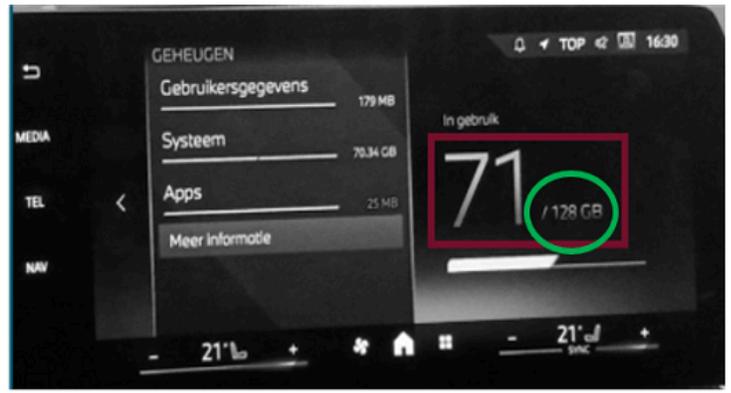
Access the Memory app in the CID. Under the “More Information” menu, check the used memory settings of the HU-H6. If the total memory settings show 16 GB instead of 128 GB, the HU-H6 memory settings are incorrect.

To restore the correct memory settings, perform a Factory Reset of the HU-H6 using the following path:

- App Menu
- System Settings
- Reset Vehicle Data
- Confirm

Recheck the Memory Capacity has changed to 128 GB.
