## SIM 51 01 26

### CRACKING SOUND IN THE HEADLINER AREA

2026-03-18

E-Series	Model Description	Production Date	Affected Option Code
U25	Countryman S ALL4, JCW Countryman ALL4, Countryman SE ALL4 Battery Electric Vehicle	SOP	402 Panoramic Moonroof

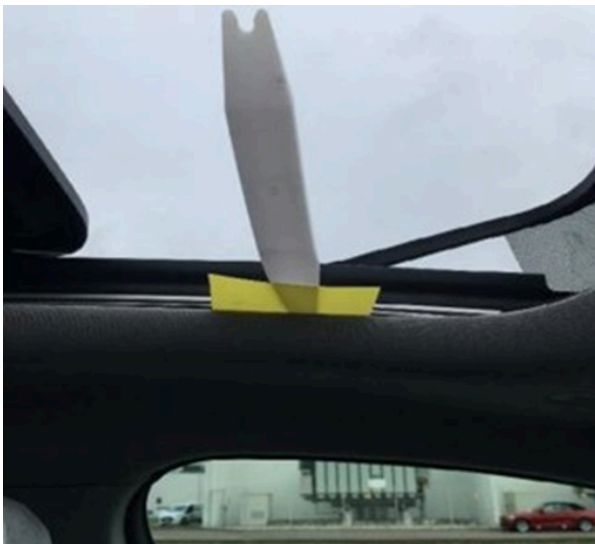
##### Cause 1:

1. The metal frame of the panorama roof cutout on the headliner is contacting the panorama roof.
2. Movement of the headliner holding clips.
3. The metal frame of the panorama roof cutout separates from the headliner.

1. Using a “clip lifter tool”, pry open the contact area. Make sure that the metal frame is not deformed in the visible area.
2. Reassemble the vehicle and to verify repair.
3. If the noise is still present after performing this repair, proceed to Cause 2.
