Technical Service Bulletin

GROUP	NUMBER
ADAS	26-AD-001G
DATE	MODEL(S)
MARCH 2026	SEE BELOW

SUBJECT: FRONT VIEW CAMERA WARNING AND CALIBRATION
(DTC C272246)

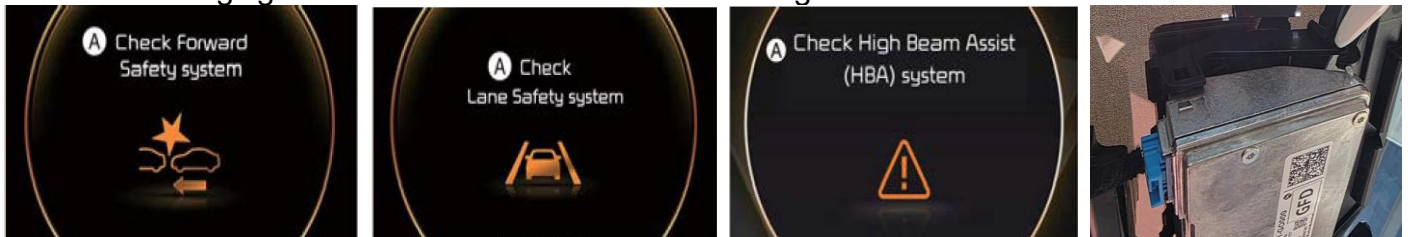
C272246 – System Out of Calibration

Possible Warning lights due to the front camera exceeding its calibration tolerance:

- 1A. Connect GDS to the vehicle and check for **DTC C272246**:
- If the DTC is **ACTIVE**, then proceed to replace the front view camera. Refer to the shop manual for the front view camera replacement procedure.
 - If the DTC is in History, then **NO** action is required.
- 1B. If **DTC C272246** is triggered, do **NOT** perform the front camera calibration using the target.
- If the front camera target calibration is performed, it will cause another **DTC C2721**.
 - **DTC C2721** – System Calibration Required LDWS (Lane Departure Warning System).

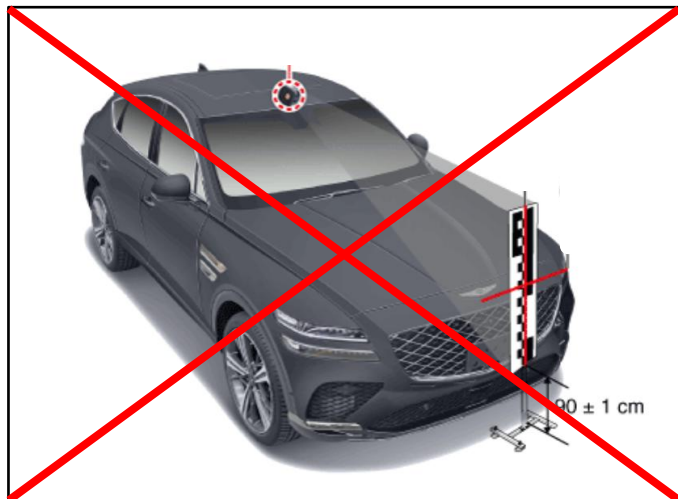
If **DTC C2721** is triggered, turn the ignition **OFF/ON** and then perform the driving calibration with the usage of the GDS.

Select “**FR/CMR – Front View Camera**”, “**Front Camera Driving Calibration (SPC)**”, then follow the instructions in the GDS to perform the driving calibration.

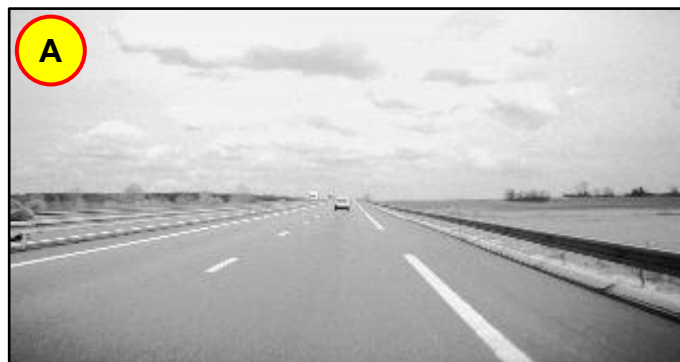
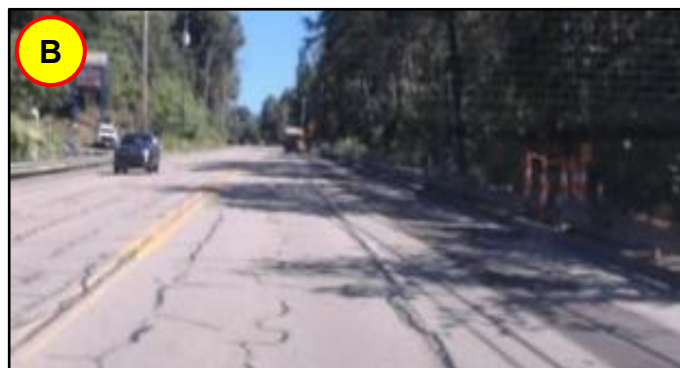
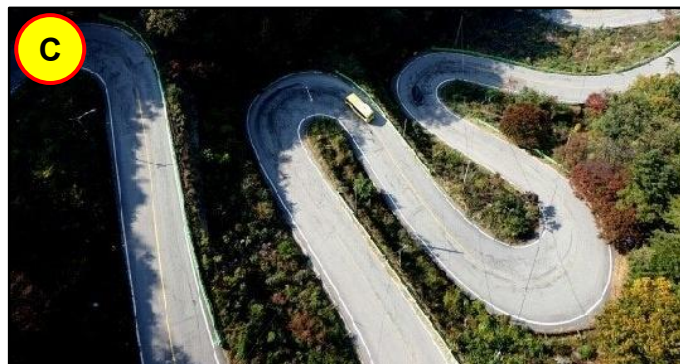
Calibration may fail when conducted on a road with too much surface damage (B) or too many curves (C).

3. Test drive the vehicles under the following conditions:
 - Time: **5 minutes**
 - Speed: Over **18.6 MPH (30 KPH)**
 - Road: Straight with minimal curves (A)
