SIB 12 04 26

DELIVERY STOP: HARNESS ROUTING

2026-03-26

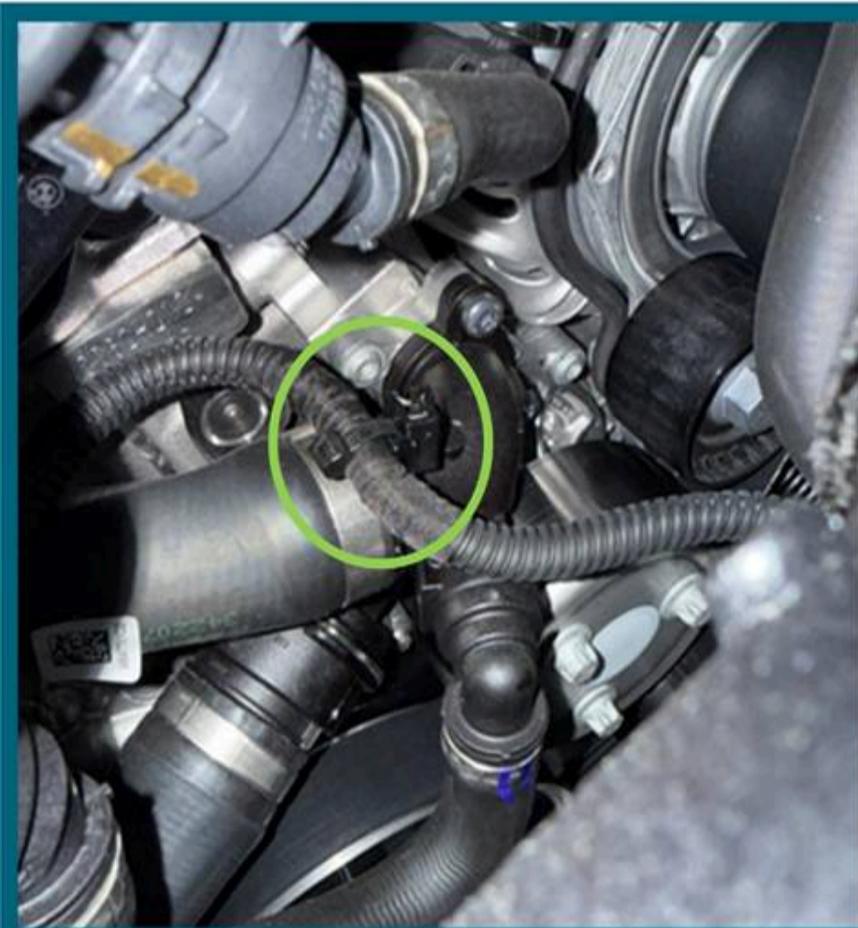
Alligator clip installed correctly.

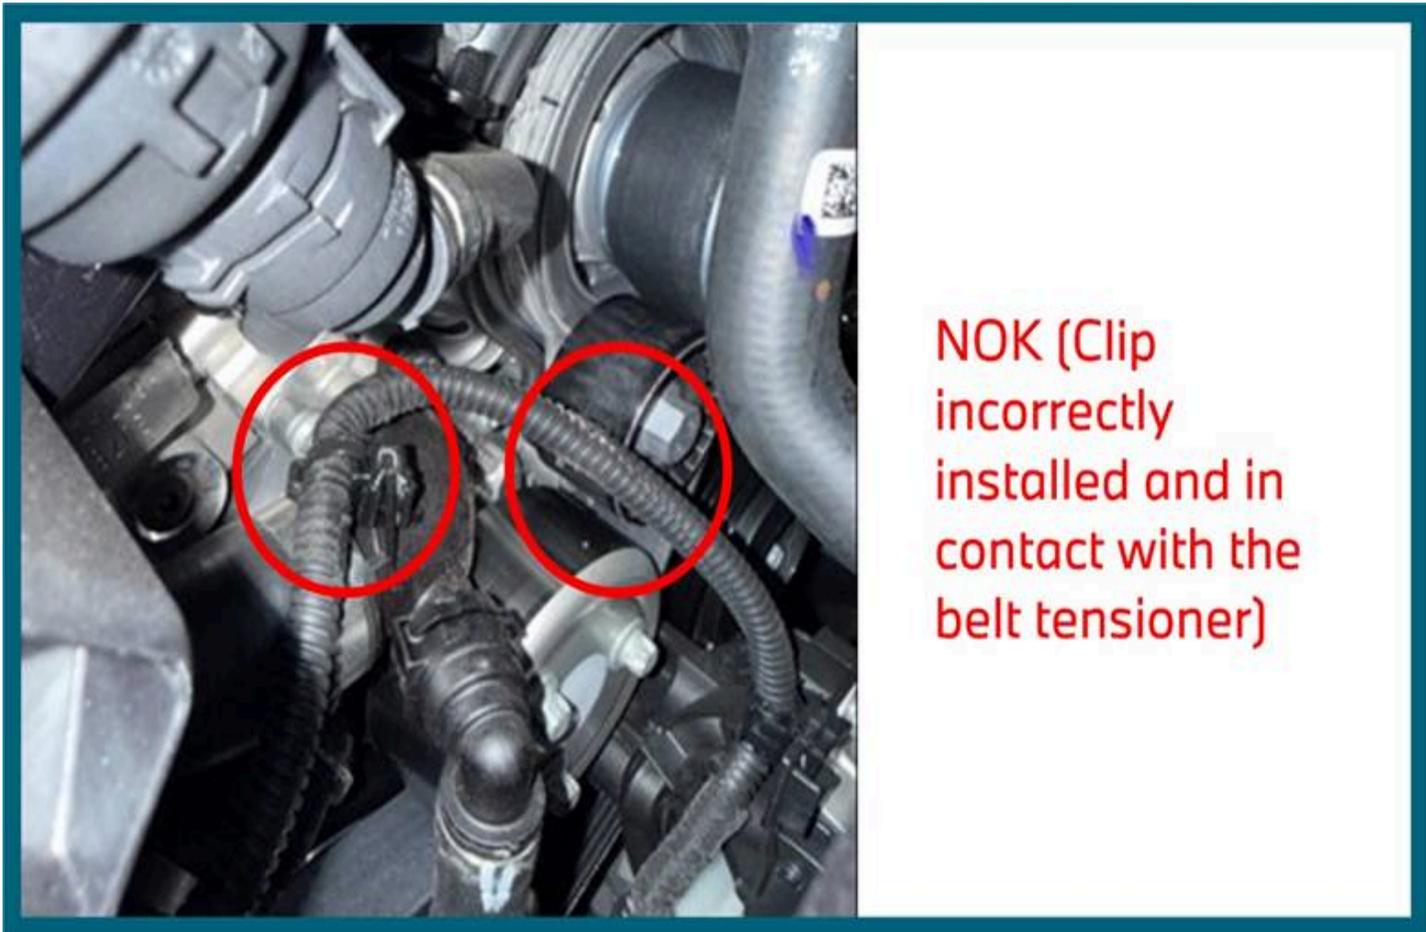
During assembly, a clip on the wiring harness for the electric water pump was misaligned.

As a result of the misaligned clip, the wiring harness for the electric coolant pump may come into contact with the belt tensioner and thereby be damaged or even severed.

If **no** damage to the wiring harness is found, only the alligator clip needs to be corrected.

If visible damage to the wiring harness is present, the Motor Sensor 2 wiring harness must be replaced in accordance with RA12 51 240 “Motor Sensor 2 Wiring Harness”.
