GROUP	MODEL
ELE	2022-2025MY Multiple Models
NUMBER	DATE
394	March 2026

## TECHNICAL SERVICE BULLETIN

### AVN5.0W DTC P17A000 DAIGNOSTIC PROCEDURE

This bulletin provides information regarding a potential illuminated Malfunction Indicator Lamp (MIL) accompanied by DTC P17A000 on some 2022-2025MY Hybrid Electric Vehicles (HEV) and Plug-In Hybrid Electric Vehicles (PHEV) equipped with AVN5.0Wide head units listed below. This condition occurs when the Global Positioning System (GPS) module within the Audio Video Navigation (AVN) head unit, sends an inaccurate signal to the Hybrid Power Control Unit (HPCU), causing the DTC to set. **There are no drivability symptoms associated with this condition.** Follow the procedures outlined in this TSB to inspect and if necessary, install the AVN5.0W software and inspect and if necessary, replace the antenna and/or the AVN5.0W head unit.

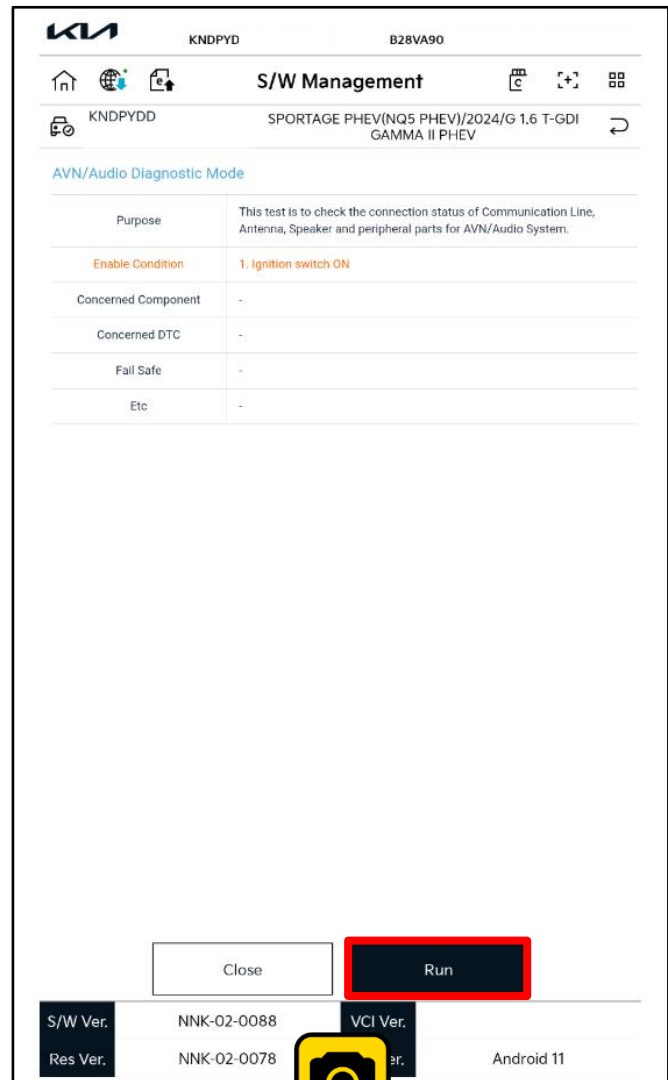
3b. Confirm if DTC **B283700** is stored.

- DTC is NOT stored (**OK**), then proceed to step 3c.
- DTC IS stored (**NG**), proceed to step 3c, then **replace** the AVN5.0W Head Unit by referring to 'AVN5.0W Head Unit Replacement Procedure' on page 9. Using KDS Tablet [Warranty Claim Attachment](#) Tab, take a photo of the stored B283700 DTC.

3c. Confirm if any DTCs listed below are stored.

B282600 - GPS Antenna Short State  
 B282700 - GPS Antenna Open State  
 B28C000 - Am/Fm Radio Antenna Short State  
 B28C100 - Am/Fm1 Radio Antenna Short State  
 B28C600 - Roof LTE/3G Antenna Short State  
 B28C700 - Roof LTE/3G Antenna Open State  
 B28C900 - C/PAD LTE antenna Short State  
 B28CA00 - C/PAD LTE antenna Open State

- DTC(s) is/are NOT stored (**OK**), then proceed to step 4.
- DTC(s) IS/ARE stored (**NG**), then **replace** the Antenna by referring to the 'Antenna Replacement Procedure' on page 10. Using KDS Tablet [Warranty Claim Attachment](#) Tab, take a photo of the stored DTC.

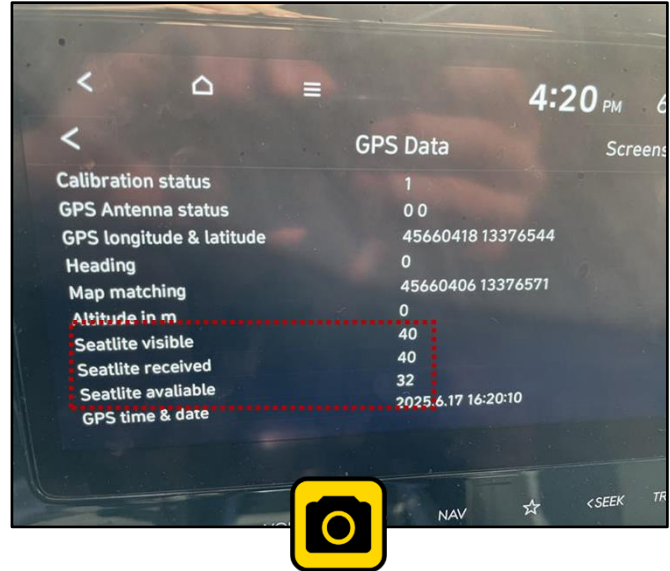
9. Confirm the 'Satellite visible', 'Satellite received', and 'Satellite available' are within specification.

Satellite visible, received and available Values

When Vehicle is <u>INDOORS</u>	≥ 5
When Vehicle is <u>OUTDOORS</u>	≥ 15

- Satellite visible, received AND available **ARE ALL** within specification (OK), then proceed to step 10.
- Satellite visible, received AND available are **NOT** within specification (NG), then proceed to the 'Antenna Replacement Procedure' on page 10. Using KDS Tablet [Warranty Claim Attachment](#) Tab, take a photo of the 'Satellite visible', 'Satellite received', and 'Satellite available' values.
