Service Bulletin

Bulletin No.: PIP6106

Subject: Diagnostic Tip LSD Engine Potential Coolant Loss Water Pump Area

Brand:	Model:	Model Year:		VIN:		Engine:	Transmission:
		from	to	from	to		
Chevrolet	Equinox	2026		All	All	1.5 LSD	All
GMC	Terrain	2026		All	All	1.5 LSD	All

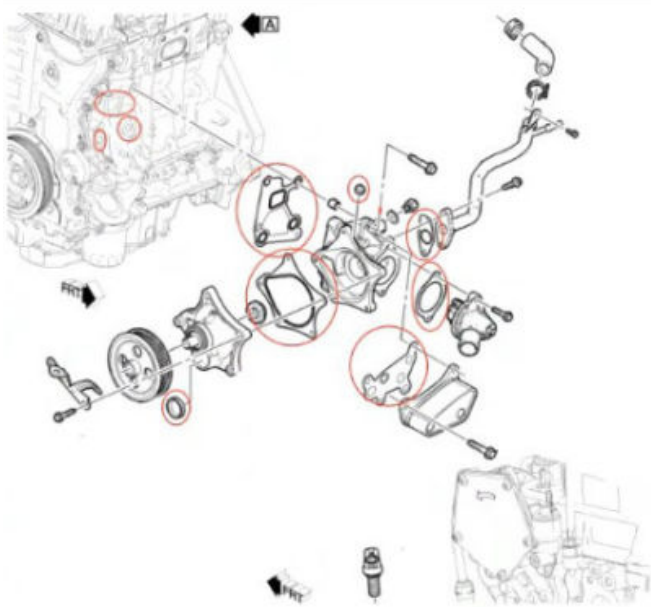
Dealers may encounter a coolant leak in the water pump housing and/or pump area. At this time to avoid unnecessary part replacement please review the following diagnostic tips:

* Please review the following graphic for potential leak point areas.

* Due to the amount of potential leak areas in the water pump and housing area, it is best to add tracer dye to the cooling system and validate the leak under pressure hot engine and cold engine.
